MEMORANDUM

| Subject: | City of Wenatchee ADA Data Review and Proposed Data Dictionary | | |

Wenatchee ADA Preliminary Data Review

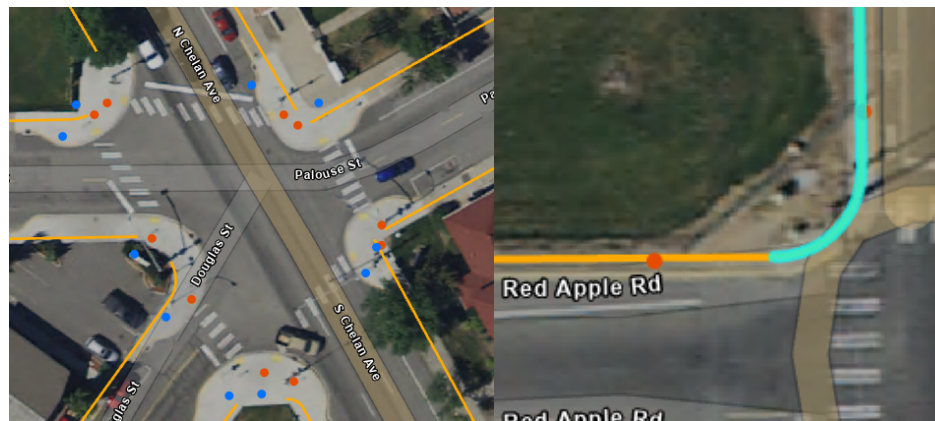
- Not always split at mid-point curb return, sometimes 3 segments at curb return and sometimes just two with missing chunk in middle or one side sweeps across into next sidewalk

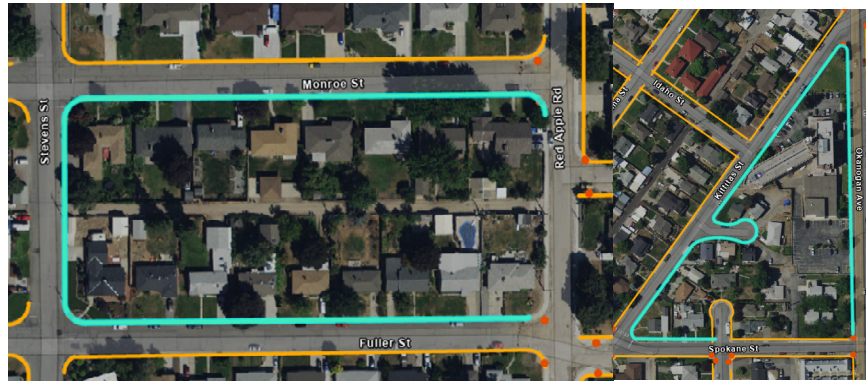
- Sometimes entire blocks are one line

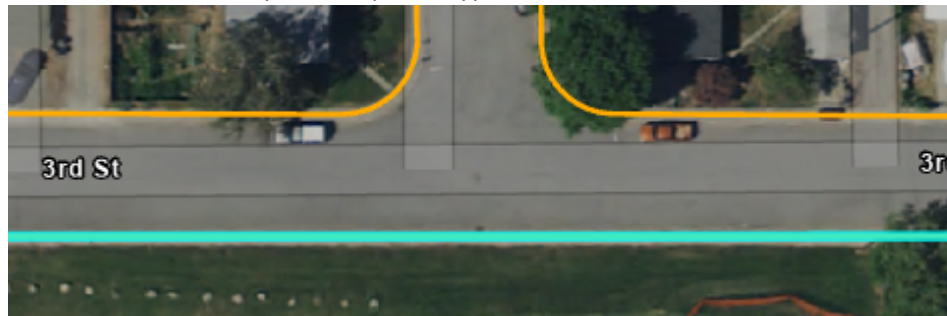
- T-intersections usually aren't split as typical road centerlines are

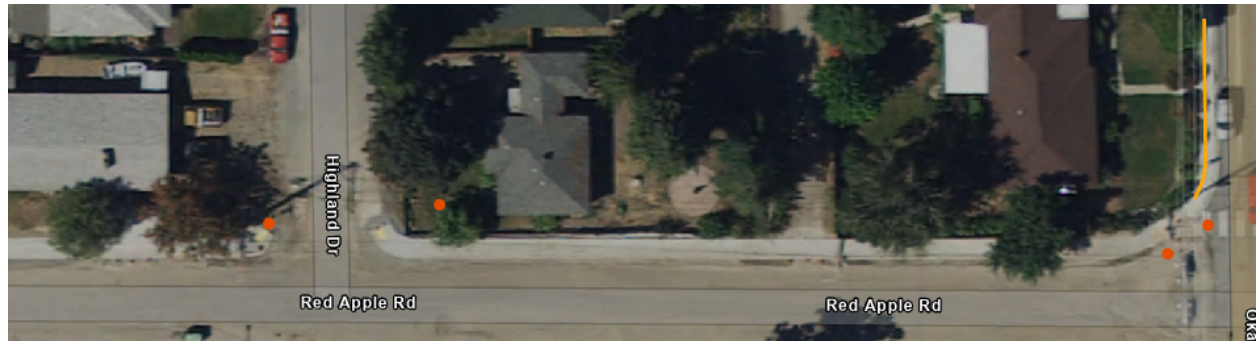
- Have spotted some areas where there's missing sidewalk data/no digitizing

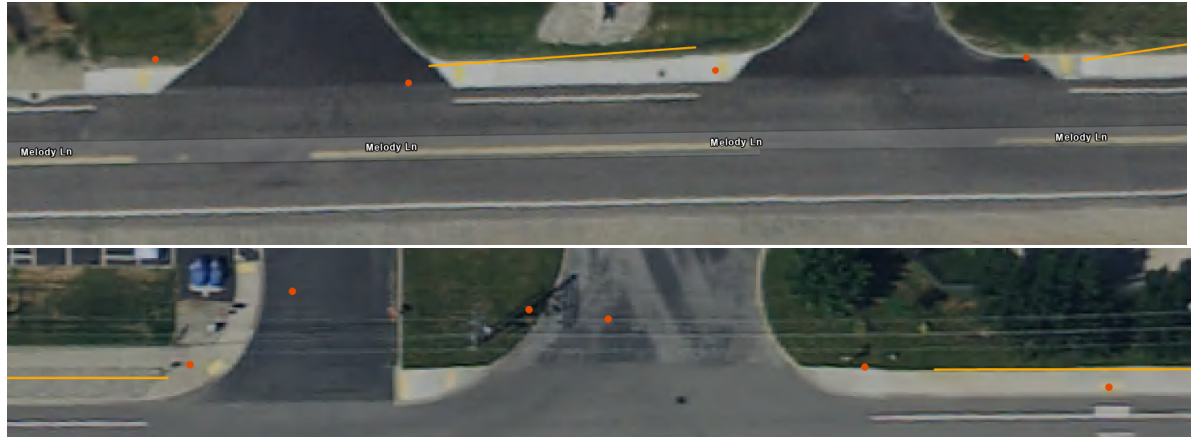
- Placement is sometimes accurate then sometimes placed poorly (red dots = curb ramp)

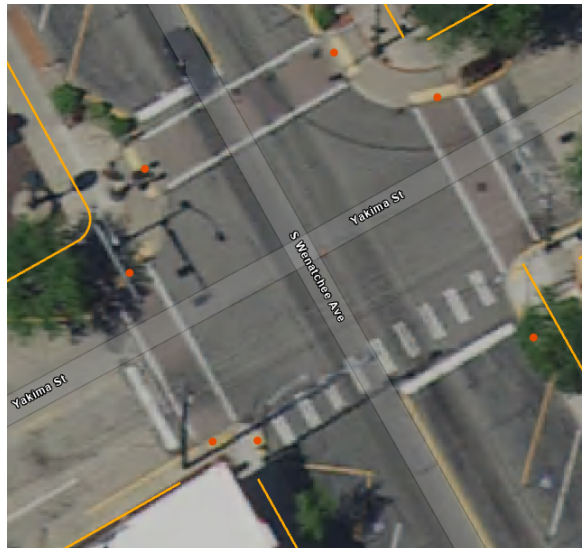
- Some placement on or close to ramp's DWS, similar to how Transpo digitizes for asset management and inventory data collection

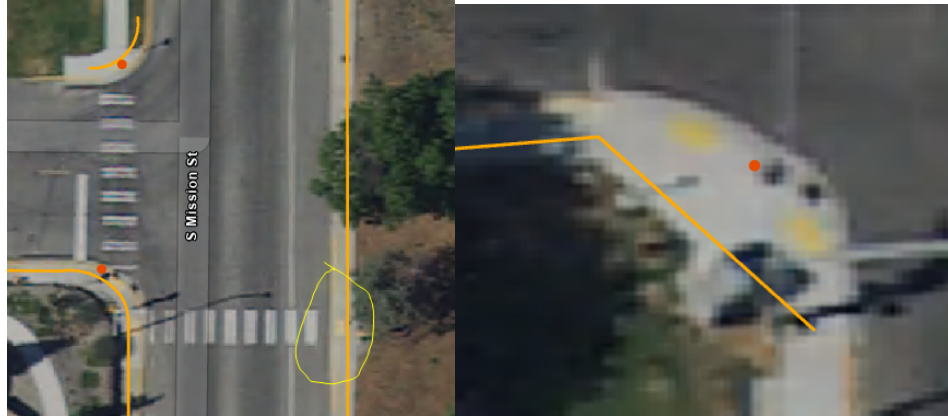
- No placements of missing ramps at PAR intersections as the data inventory normally has and needs for ADA Transition Plan cost estimating
- There appears to be at least a few ramps missing from the dataset

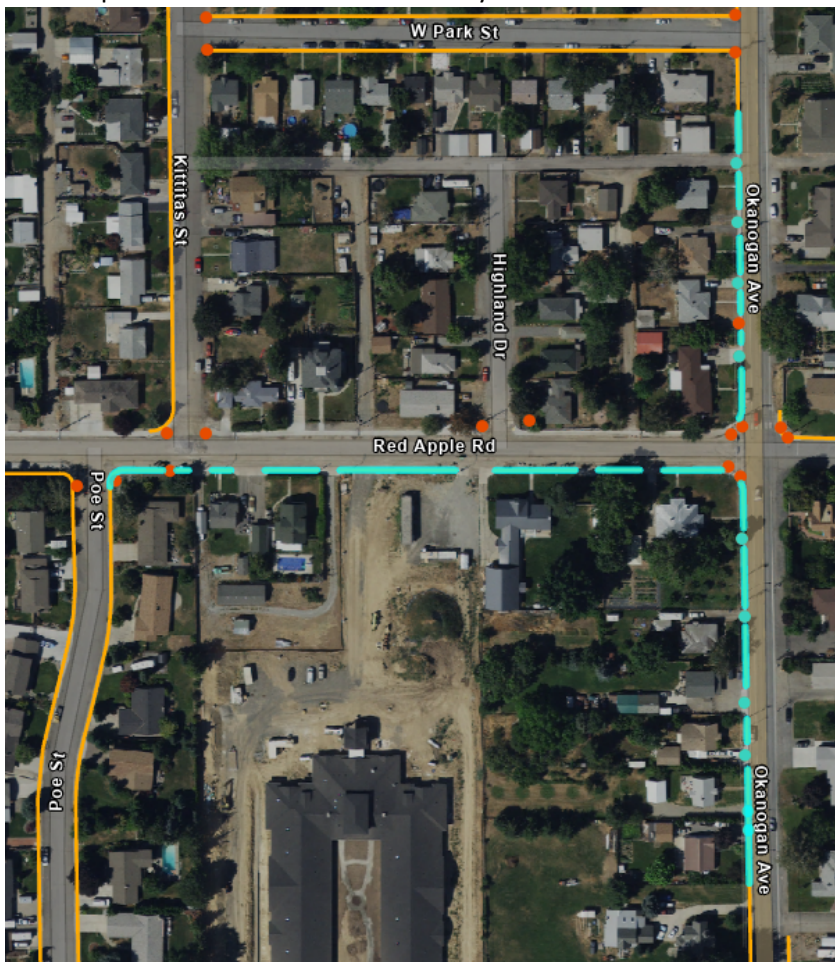
- Red Apple Rd from Kittitas St to Okanogan Ave and Okanogan Ave from W Park St to Hainsworth Street has unique data, the sidewalks and curb ramps here are the only data points with mostly all fields filled in. All other features are Null for most fields.
 - This area's sidewalks are all split at driveways and some of them have curb ramp points placed in the middle of driveways

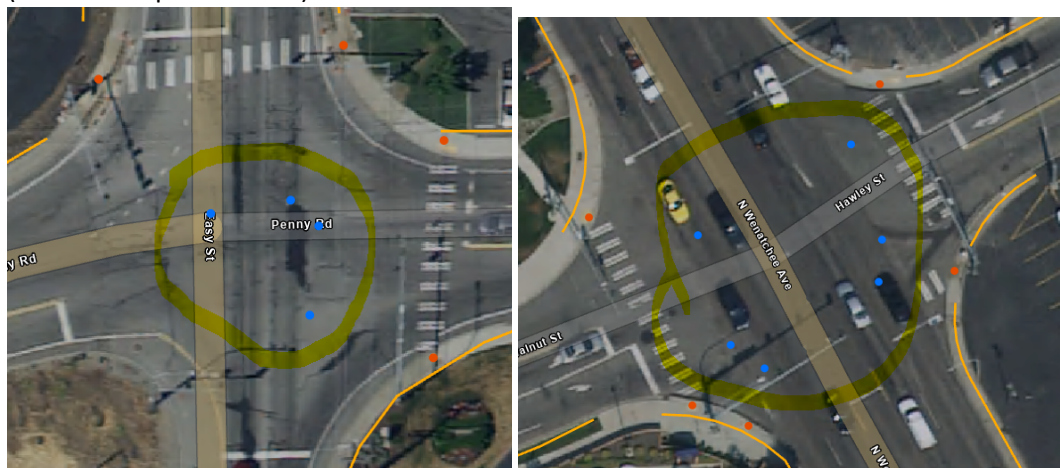
- Missing other valuable attribute field typically needed for data collection / ADA self-evaluation
- Digitization Quality – Needs Improvement
 - Inaccurate digitizing, often placed in the middle of intersections, but placed in a way where it could be possible to determine the intended location with careful inspection (blue dots = push button)

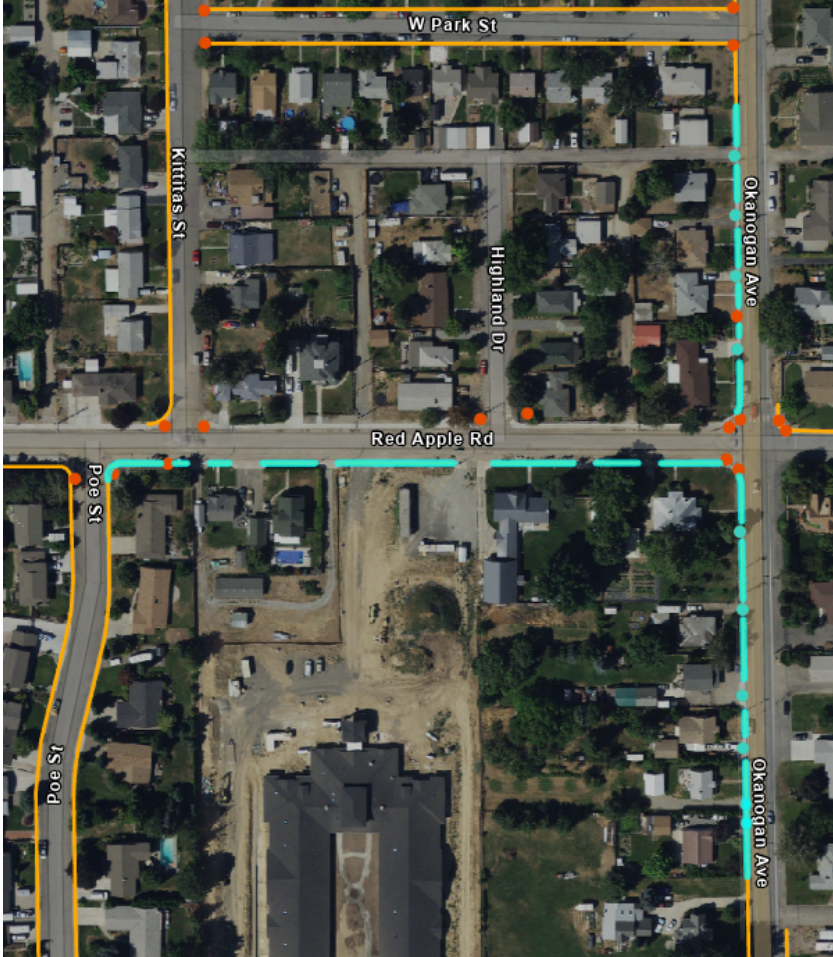
- Red Apple Rd from Kittitas St to Okanogan Ave and Okanogan Ave from W Park St to Hainsworth Street has unique data, the sidewalks and curb ramps here are the only data points with mostly all fields filled in. All other features are Null for most fields.
 - This area's sidewalks are all split at driveways and some of them have curb ramp points placed in the middle of driveways
