WENATCHEE HISTORIC PRESERVATION BOARD
REGULAR MEETING
June 7, 2023

- V. **NEW BUSINESS**
 - A. Review of Parliamentary Procedure – staff presentation (30 minutes)
 - B. Workshop – Fuller-Quigg Façade Updates (30 minutes)

RESTORATIONS TO BRING A COHESIVE OVERALL DESIGN

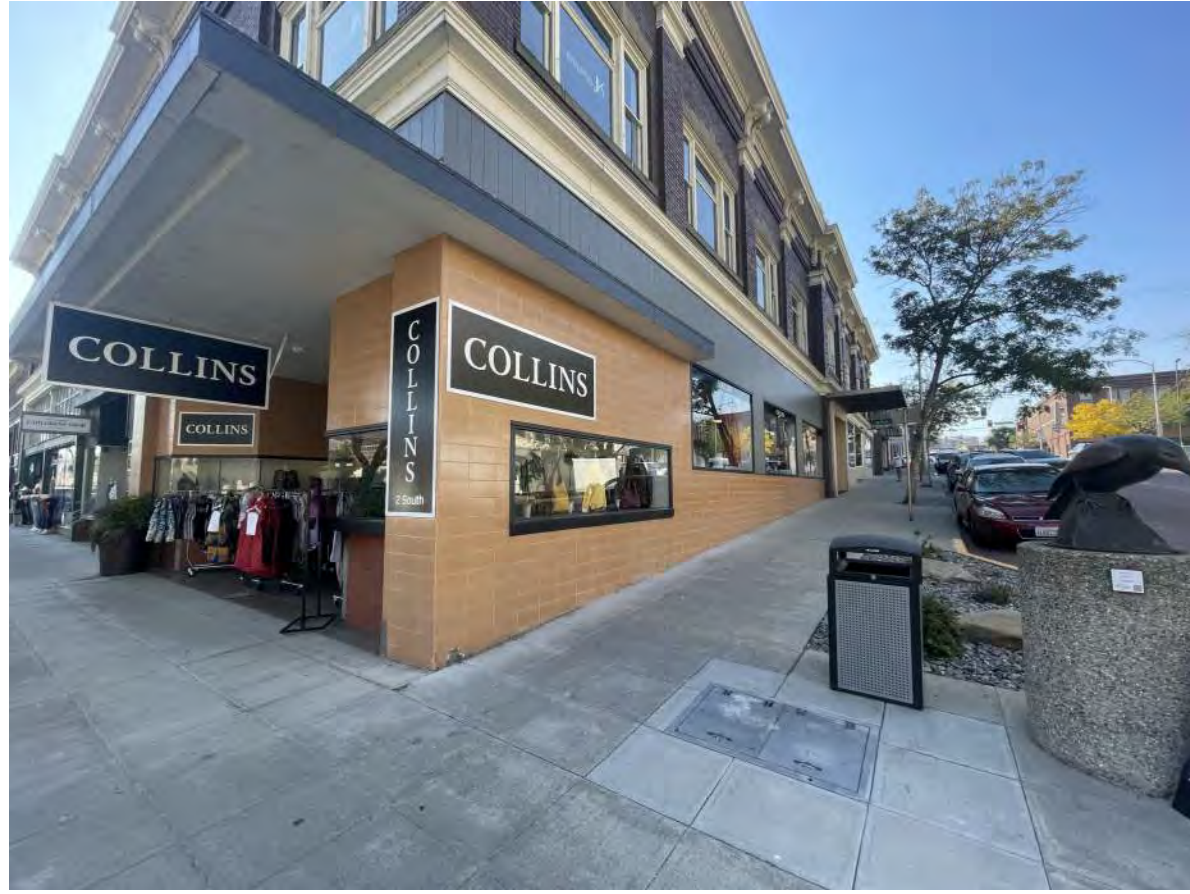
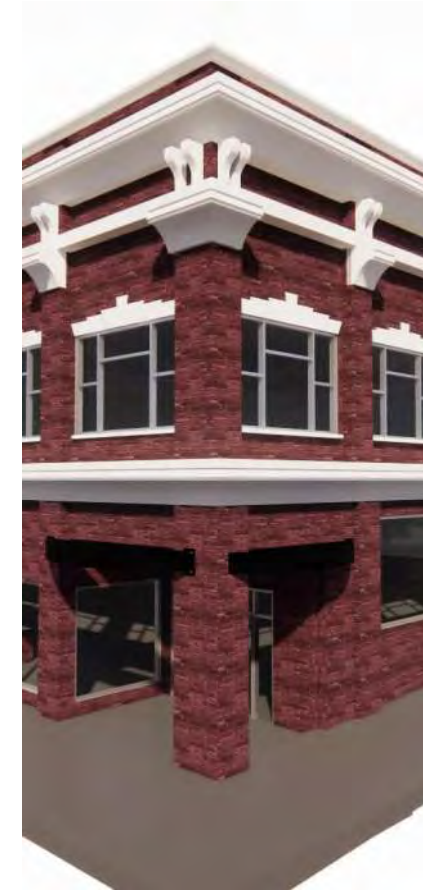
ORIGINALLY THE CORNER OF SOUTH WENATCHEE AVE AND PALOUSE STREET EMBODIED A MONUMENTAL STREET CORNER THAT OVER THE YEARS HAS BEEN BUILT TO RECESS MORE INTO THE BUILDING. THE FACADE UPDATES WOULD INCLUDE RESTORING THE CORNER BACK TO ITS ORIGINAL STATE BY REVEALING THE STRUCTURAL COMPONENTS, AND INCORPORATING UPPER WINDOWS AND MATCHING AWNINGS TO PROVIDE MORE DESIGN CONNECTIONS BETWEEN SOUTH WENATCHEE AVE AND PALOUSE STREET.

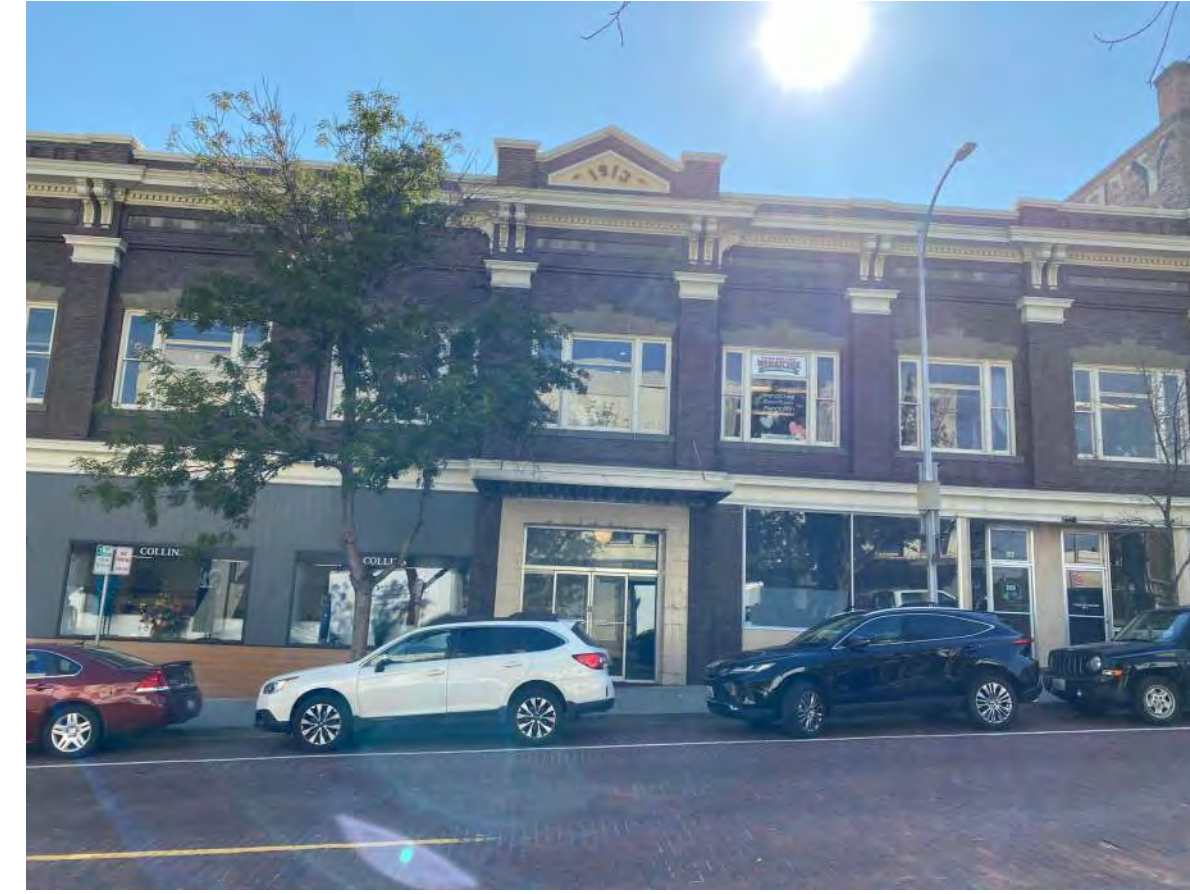
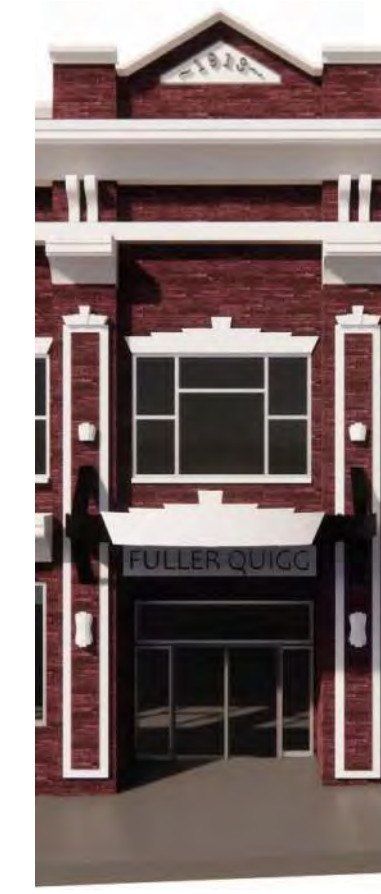
THE ENTRANCE OF FULLER-QUIGG ON PALOUSE STREET HAS BECOME LESS APPARENT TO THE PUBLIC AS IT DOES NOT PROVIDE SUBSTANTIAL STREET PRESENCE FOR THOSE NEEDING TO ACCESS THE SECOND LEVEL OF THE BUILDING. THE PROPOSED FACADE UPDATES WOULD INCLUDE SUBSTANTIAL SIGNAGE, SCONCES AND A NEW AWNING THAT WOULD TIE INTO THE ORIGINAL ART DECO DESIGN.

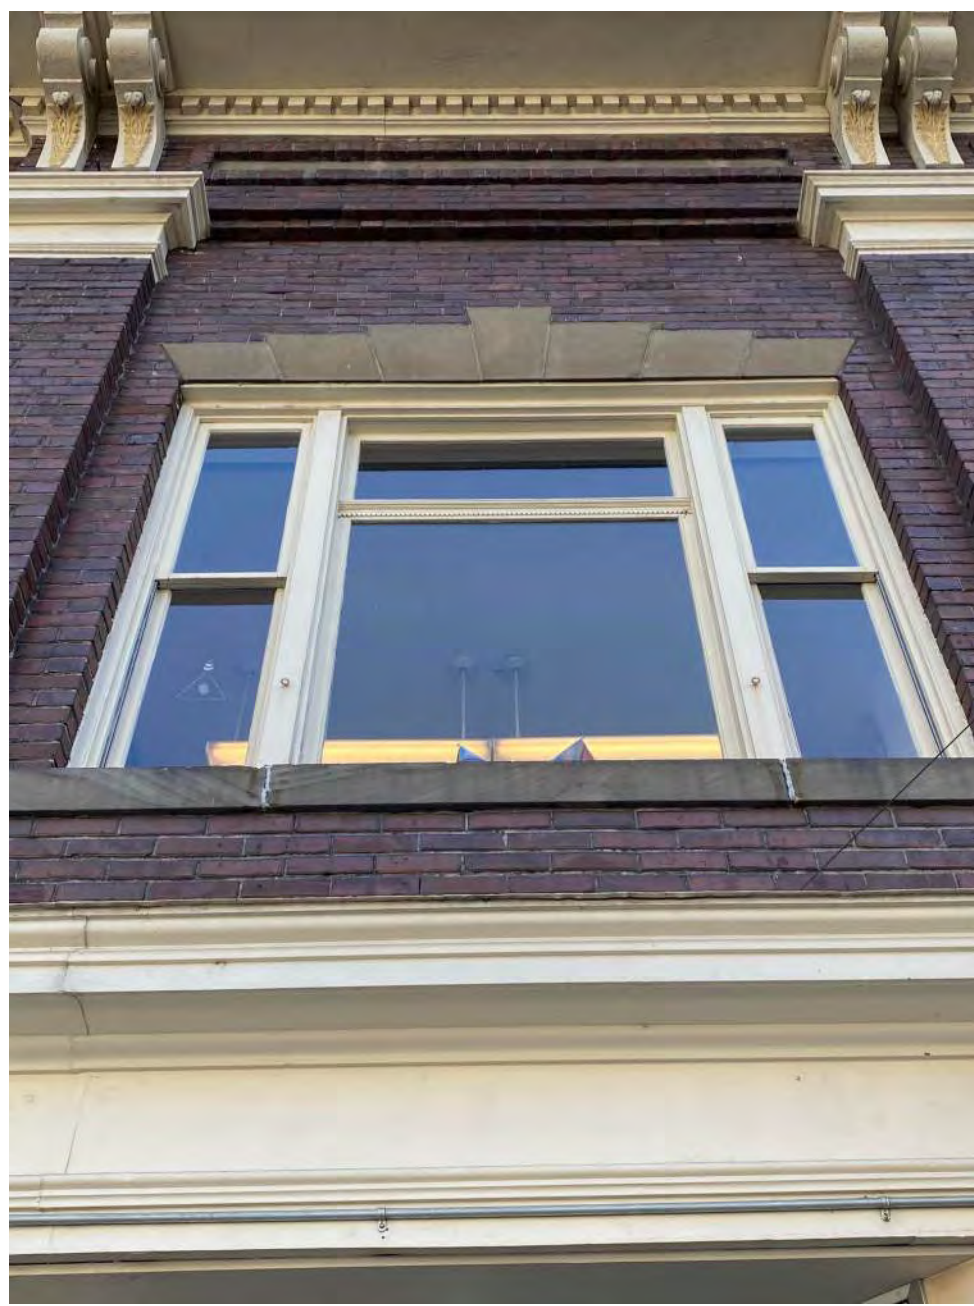
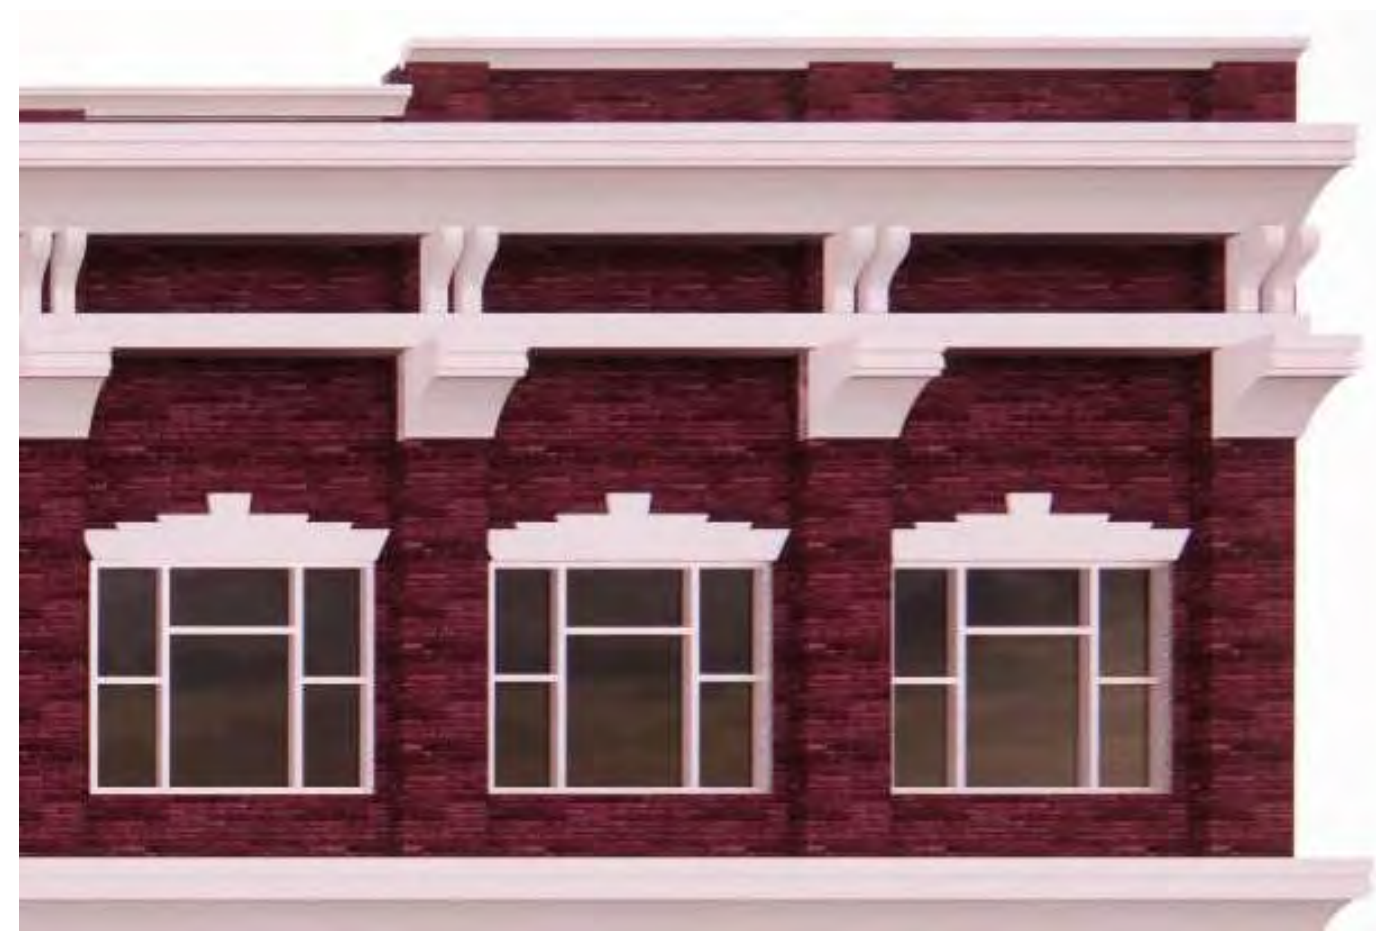
THE BUILDINGS ORIGINAL WINDOW ANCON BRACKETS HAVE BECOME WEATHERED OVER TIME, RESULTING IN A LESS VISIBLE ATTRIBUTE OF DESIGN. FOR THE FACADE UPDATES IT IS BEING PROPOSED THAT THE ORIGINAL WINDOW PEDIMENTS AND SILLS RECEIVE A FRESH COAT OF PAINT TO MATCH THE OTHER DESIGN ELEMENTS OF THE BUILDING.

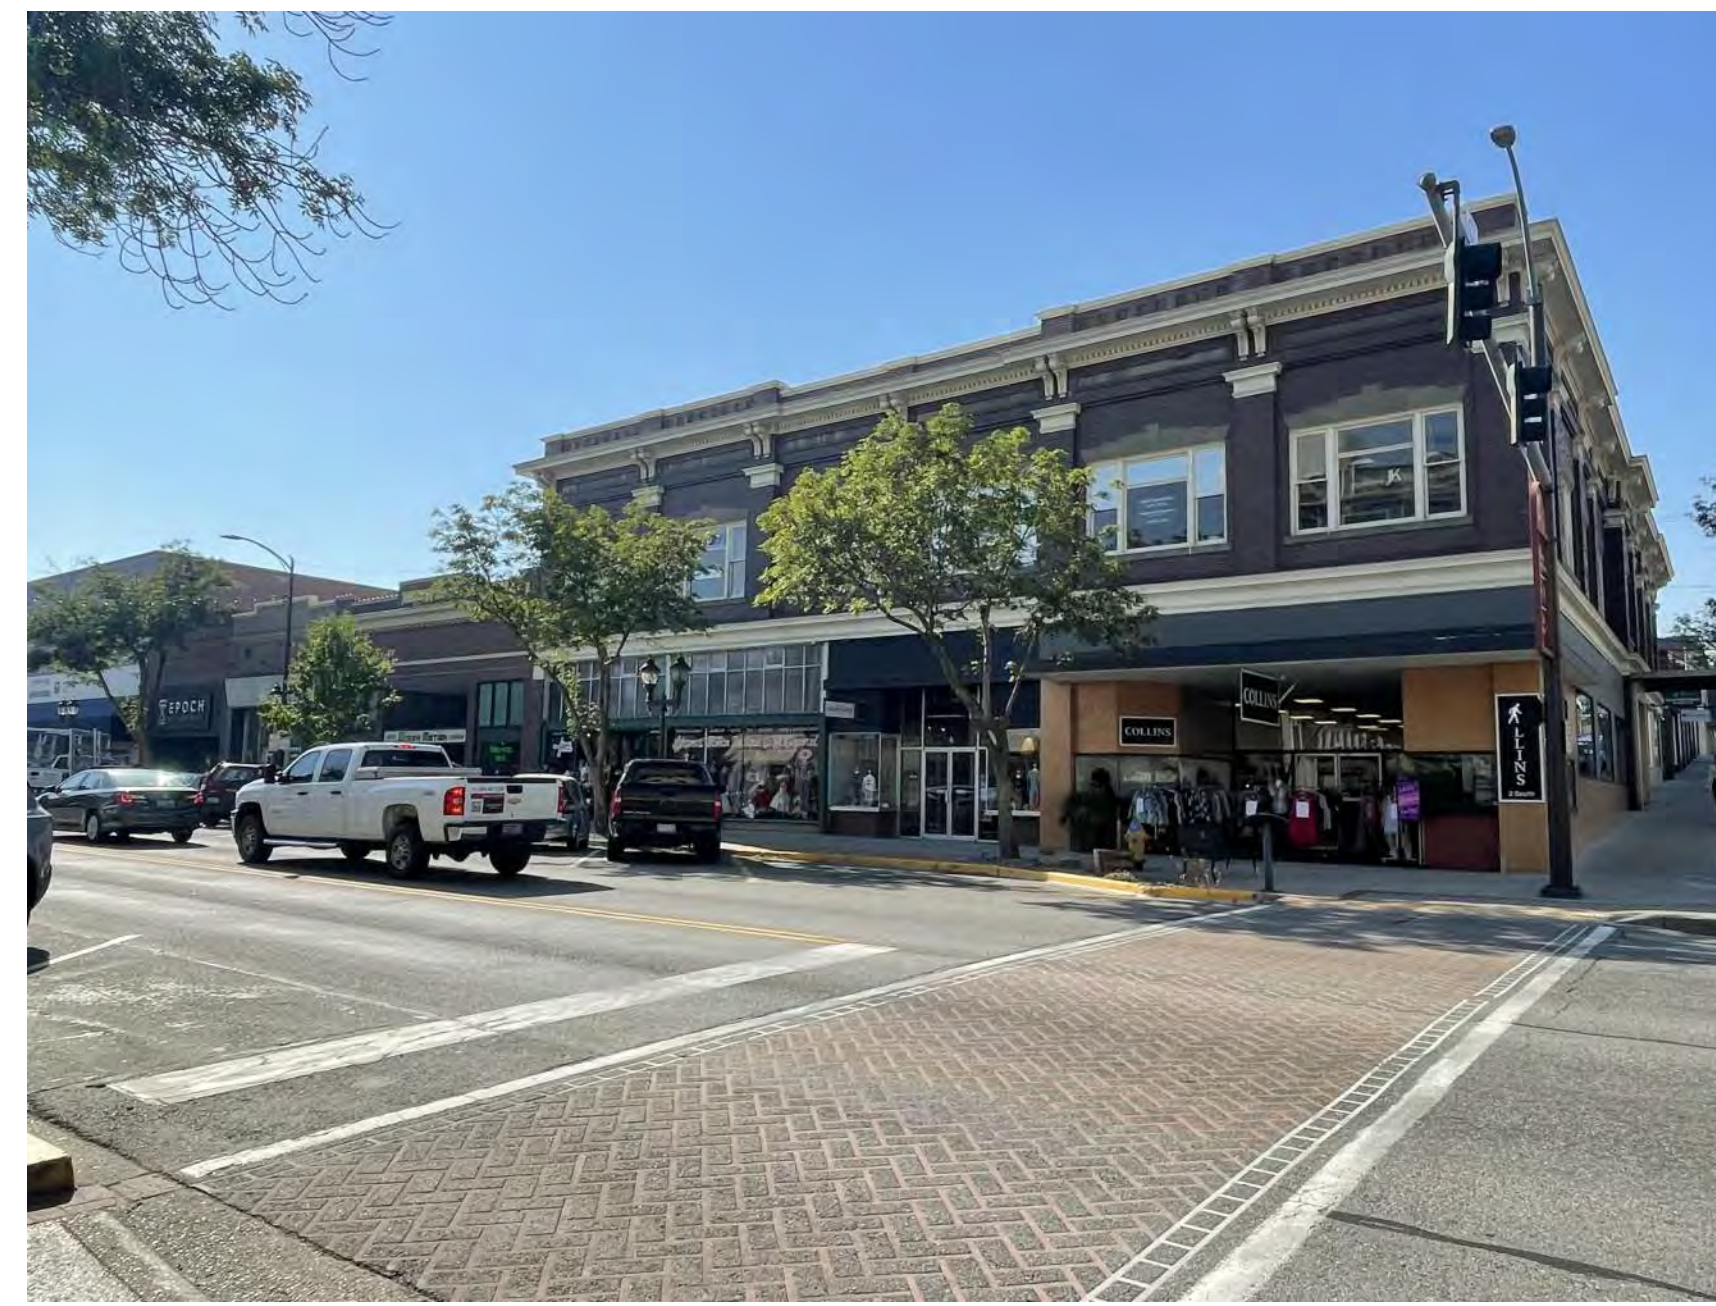
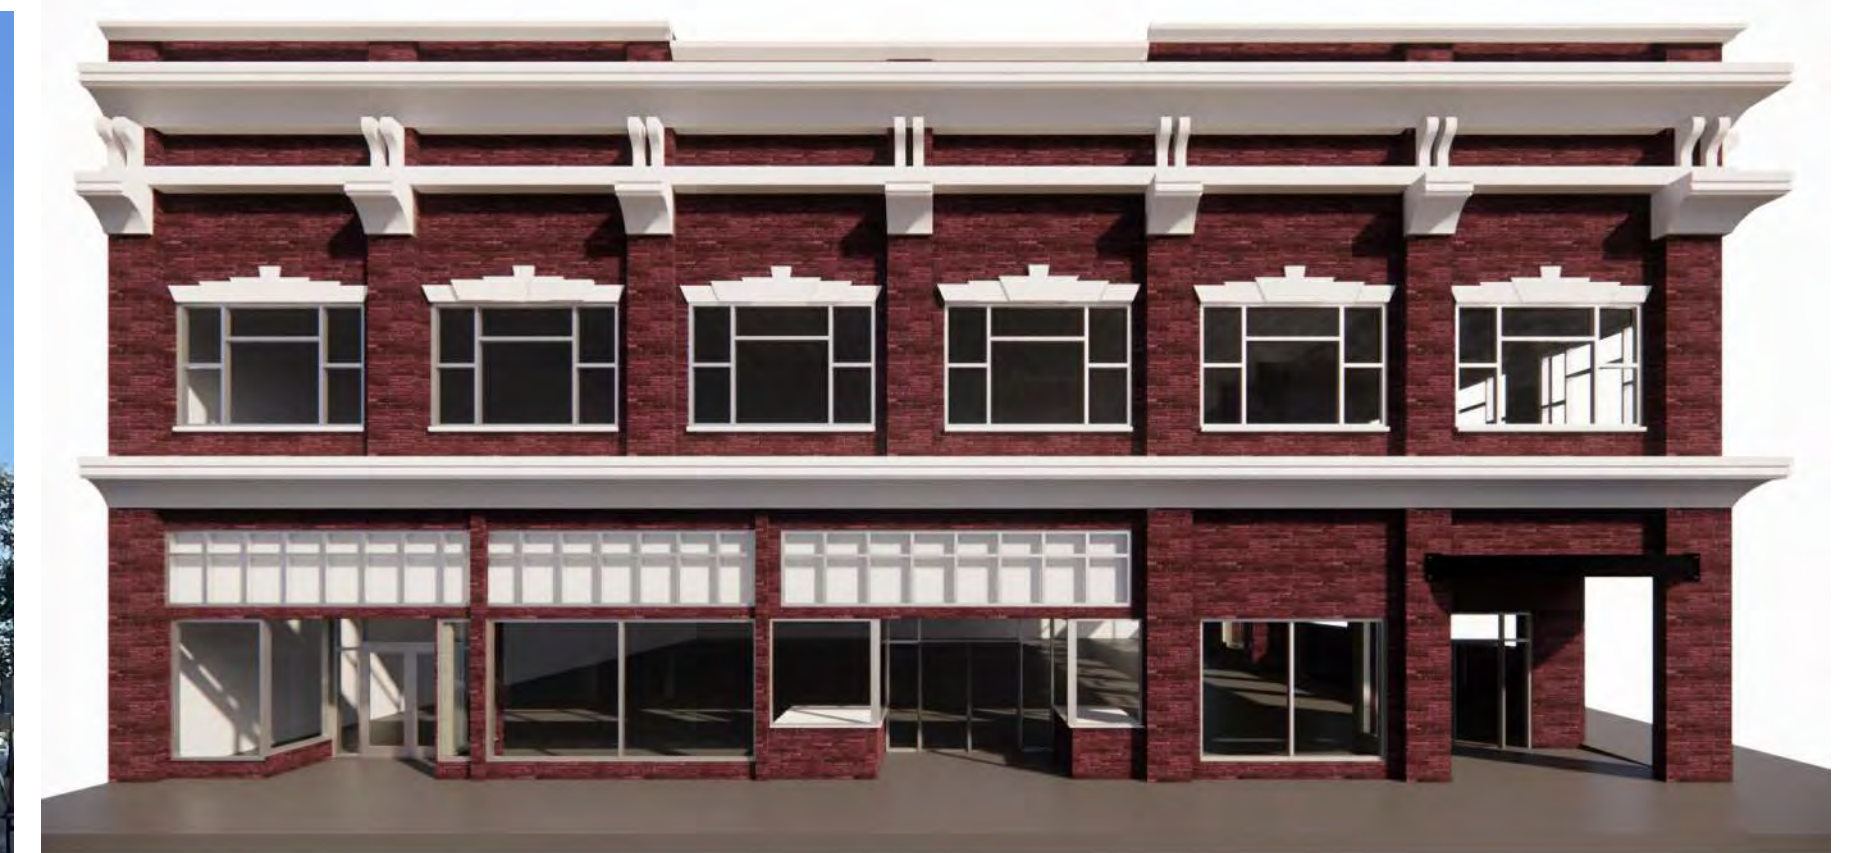
WITH THE INCORPORATION OF A BRICK VENEER MATCHING THE EXISTING BUILDING, UPPER FACADE WINDOWS, A FRESH COAT OF PAINT, NEW AWNINGS AND A RECONFIGURE OF THE CORNER ENTRANCE, THE FULLER-QUIGG BUILDING WILL CONTINUE TO BE ONE OF THE MOST ICONIC BUILDINGS IN DOWNTOWN WENATCHEE.

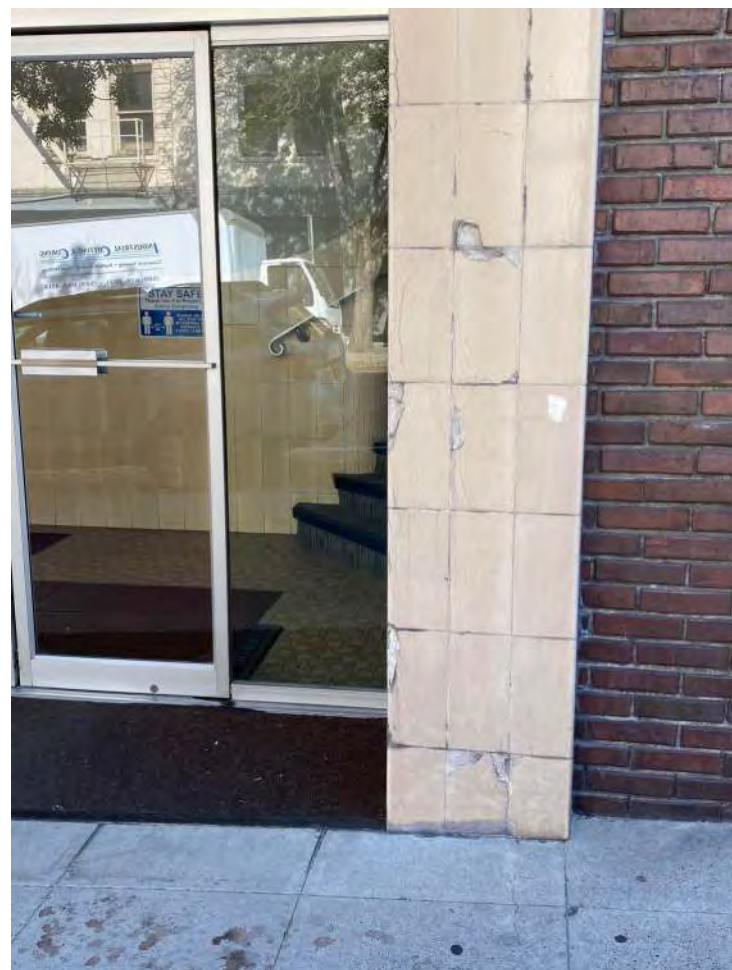
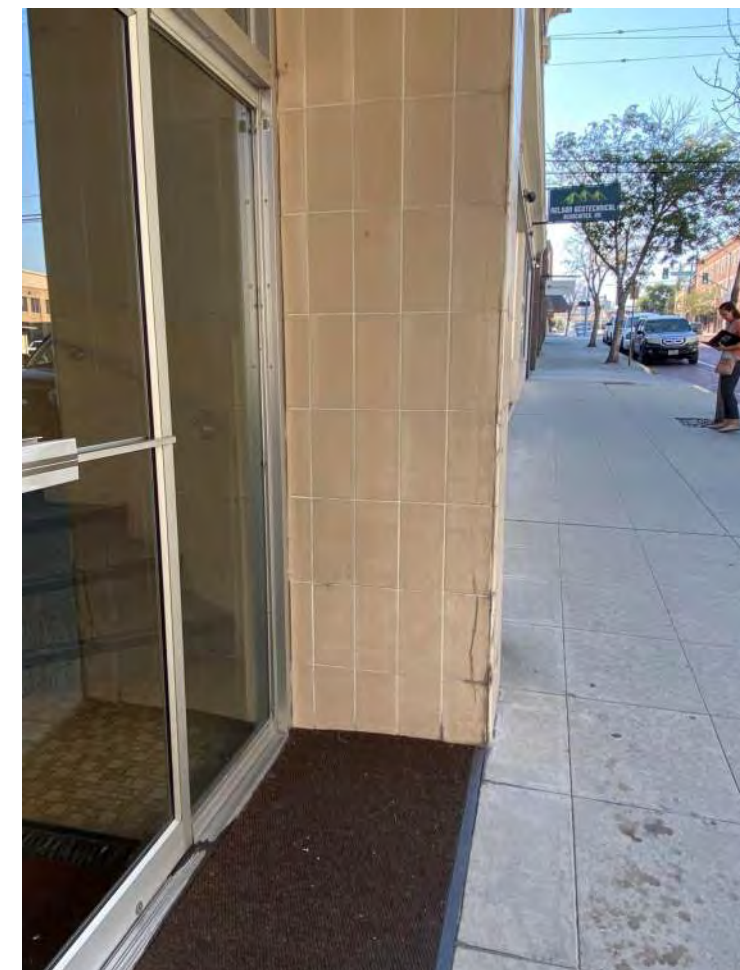
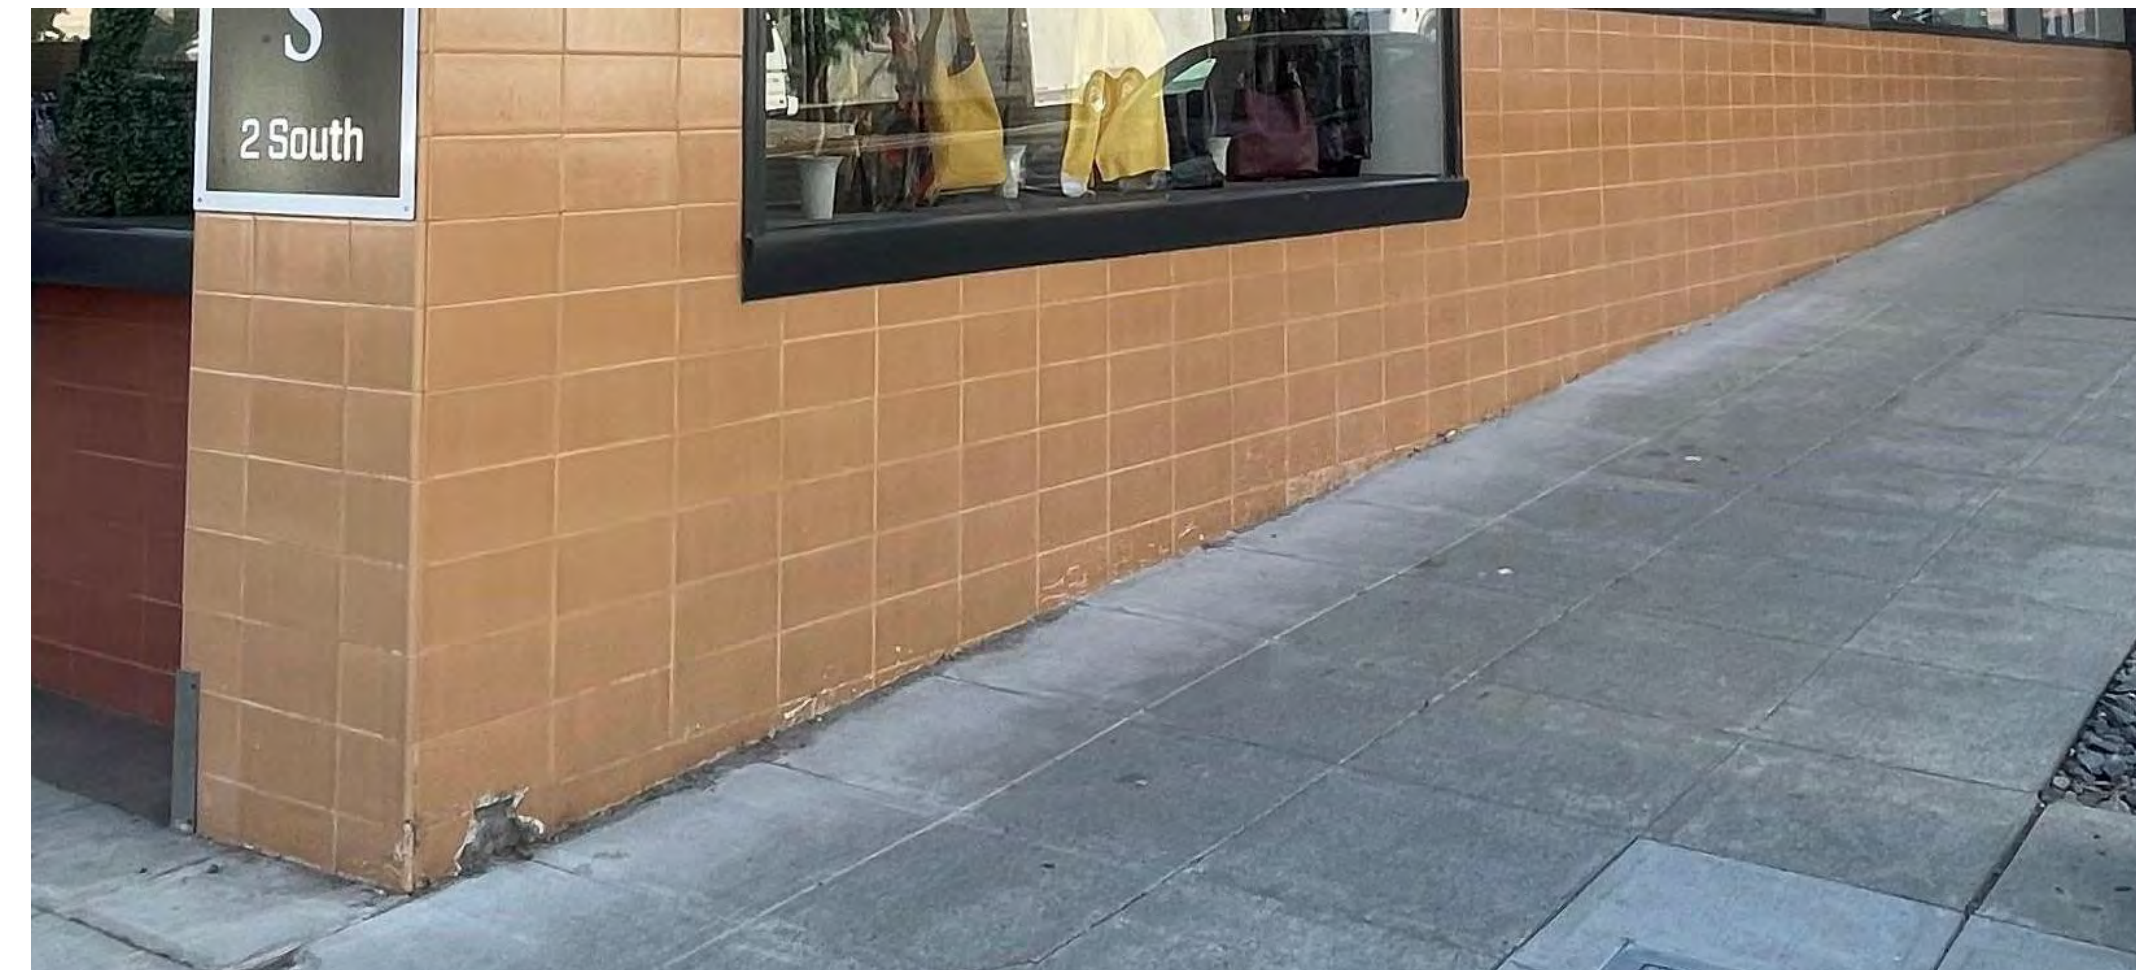
REQUIRED MATERIAL REPAIRS

YEARS OF WEATHERING HAS CREATED THE TILE TO BECOME DAMAGED BEYOND REPAIR AND WILL REQUIRE REPLACEMENT TILE. WHILE THE ORIGINAL BRICK IS BENEATH THE PEACH COLORED TILE THAT IS CURRENTLY INSTALLED, THERE IS NO POSSIBLE WAY TO RESTORE THE ORIGINAL BRICK WITHOUT DAMAGING ITS INTEGRITY. BEING PROPOSED WOULD BE A THIN BRICK VENEER THAT COULD REPLICATE THE BUILDINGS ORIGINAL BRICK.

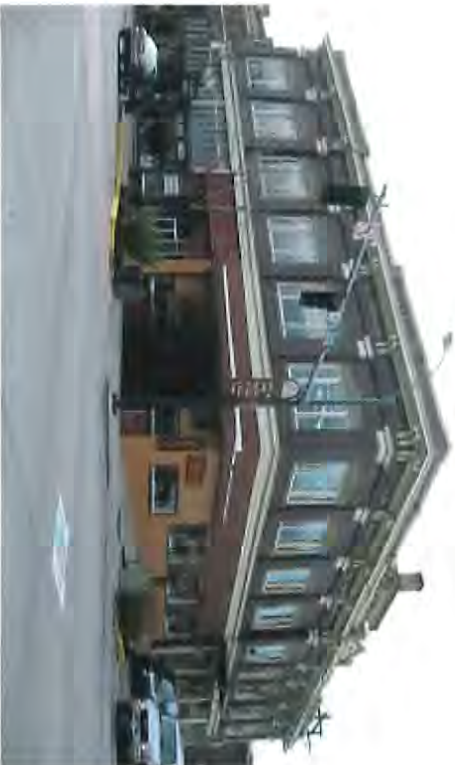
View of East (front) and North (side) facades

This two-story, Italianate style, masonry building rises from a poured concrete foundation and is rectangular in plan. Oriented to the east and north, the red brick-clad building is situated on the southwest corner of Wenatchee Ave. and Palouse St. The building's most prominent features are the projecting cornice with scroll-shape brackets and the pilasters on the second story. The plasters continue up to the parapet which also features inset brick rectangles. The north side parapet is distinguished by a pediment in the center which is inscribed with the year the building was built, "1913." A beltcourse separates the first and second stories. The storefronts on the east and north facades have been altered with the exception of the southernmost storefront on the east side. This storefront retains its original configuration, wood-framed storefront windows, recessed entrance, brick bulkheads, and transom windows. The altered storefronts have aluminum storefront windows and are clad in either T-1-11 siding or tile. Each storefront has its own entrance. There is one entrance to the upper floor in the center of the north facade.

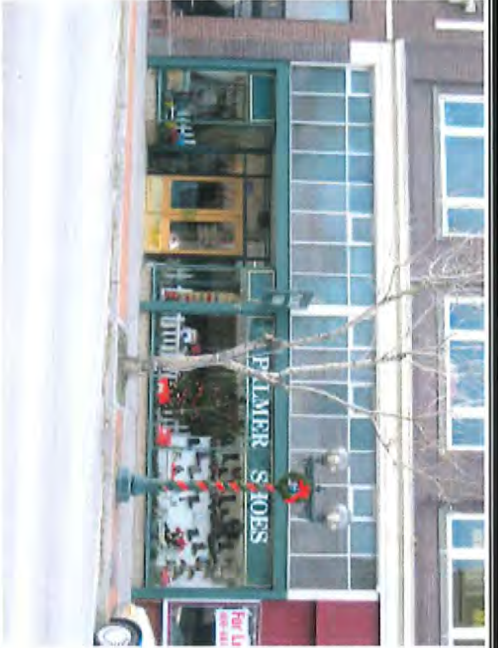
View o Storefront detail
Photography Neg. No (Roll No./Frame No.): Nov06-031
taken 11/14/2006
Comments:

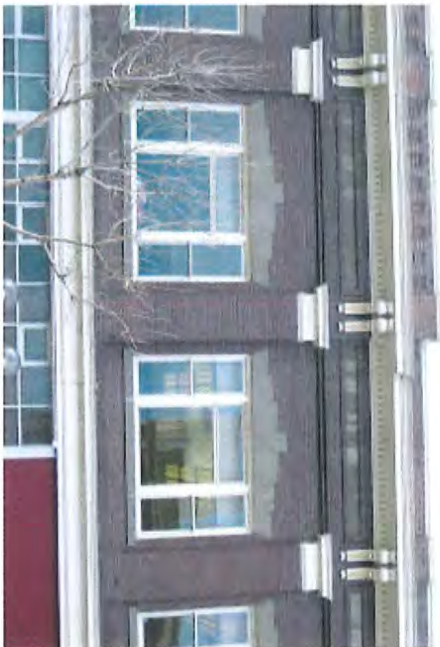
View o Second story cornice and window details
Photography Neg. No (Roll No./Frame No.): Nov06-032
taken 11/14/2006
Comments:

Above the second floor windows and masonry walls there is an entablature. A corbeltable carries the architrave which is separated from the frieze by a small molding. Above the frieze is a large protruding Romanesque cornice. The cornice is also carried by coupled ancons, scrolled in a _____ pattern. The coupled ancons are directly above the pilasters but do not actually bear on the capitols. Above the classic cornice is a stepped bahut, or parapet wall which advances and recedes creating a broken skyline. The wall is punctuated by protruding pilasters which are a non-structural, visual extension of the pilasters below the cornice.

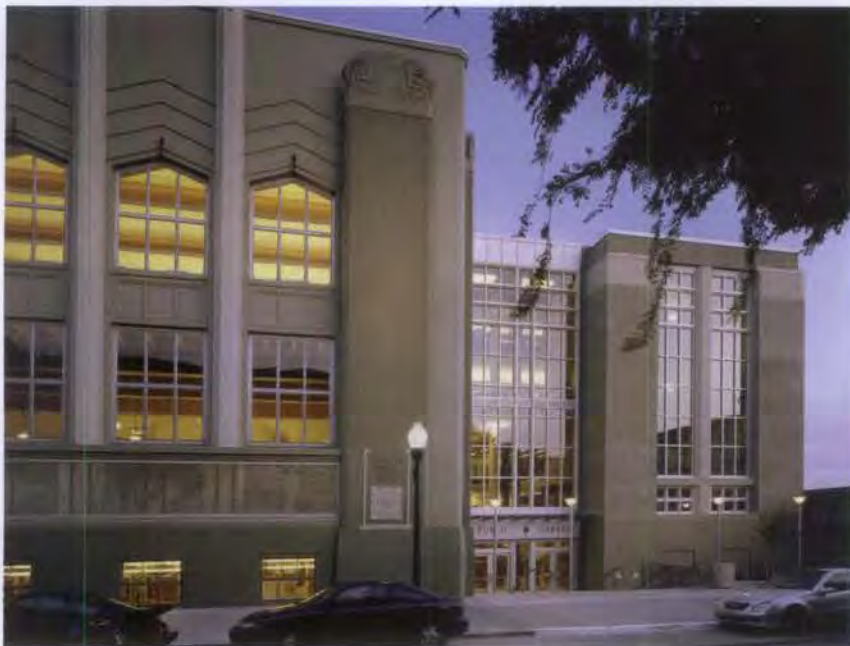
Figure 1. The addition to the right with its connecting hyphen is compatible with the Collegiate Gothic-style library. The addition is set back from the front of the library and uses the same materials and a simplified design that references, but does not copy, the historic building. Photo: David Wakely Photography.

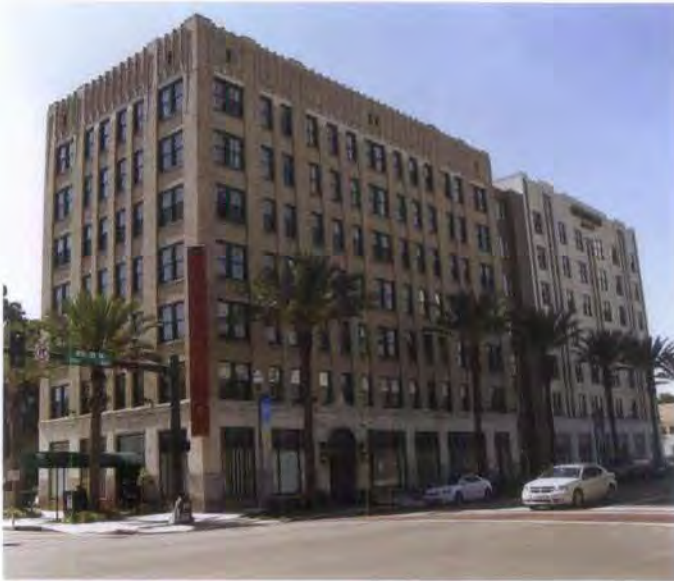
Figure 2. The new section on the right is appropriately scaled and reflects the design of the historic Art Deco-style hotel. The apparent separation created by the recessed connector also enables the addition to be viewed as an individual building.

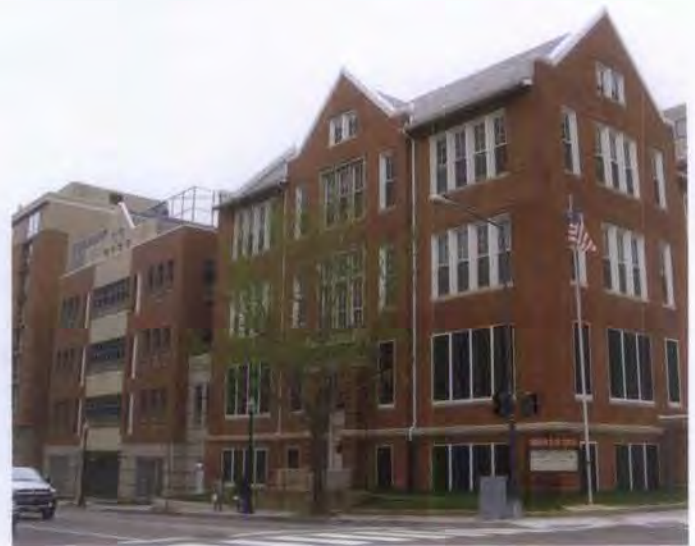
Figure 3. The red and buff-colored parking addition with a rooftop playground is compatible with the early-20th century school as well as with the neighborhood in which it also serves as infill in the urban setting.

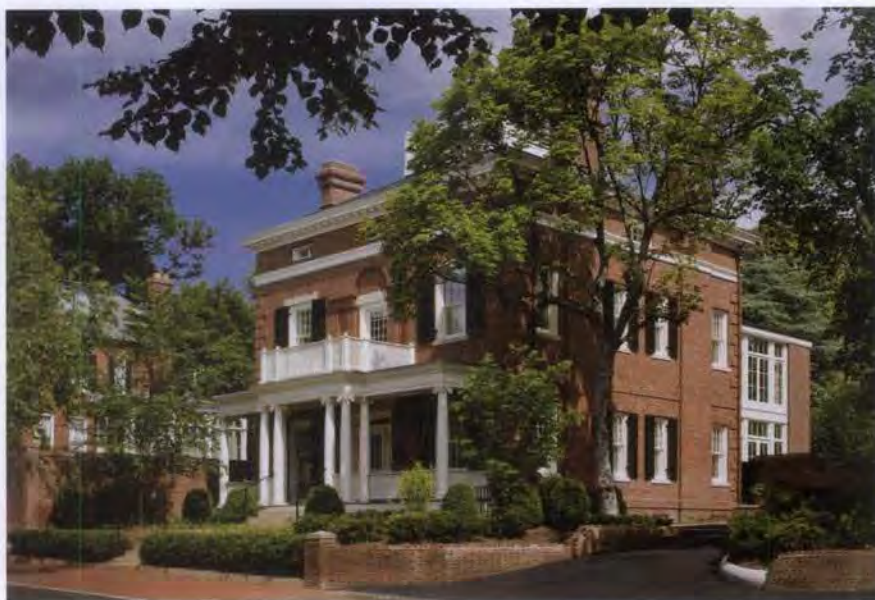
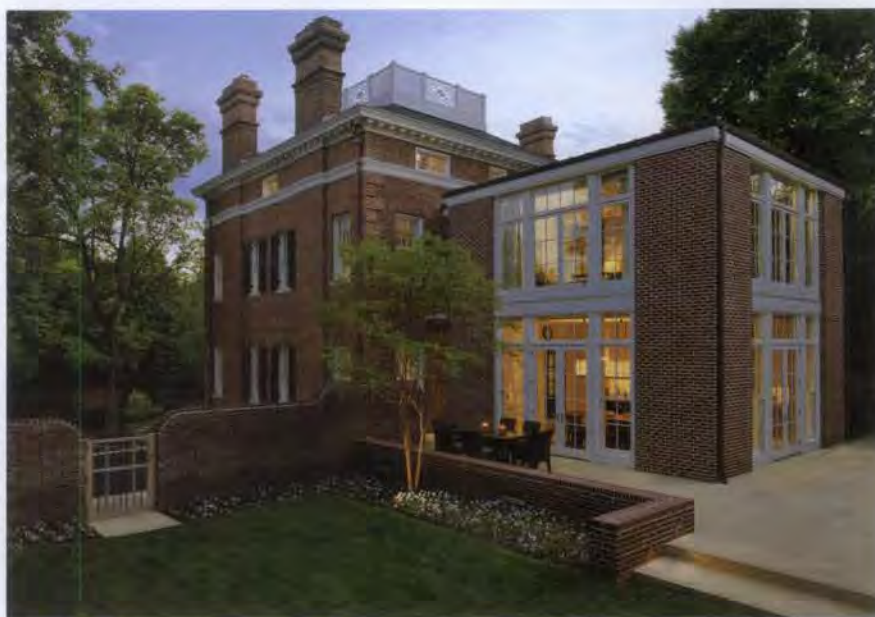
Figure 4. This glass and brick structure is a harmonious addition set back and connected to the rear of the Colonial Revival-style brick house. Cunningham/Quill Architects. Photos: © Maxwell MacKenzie.

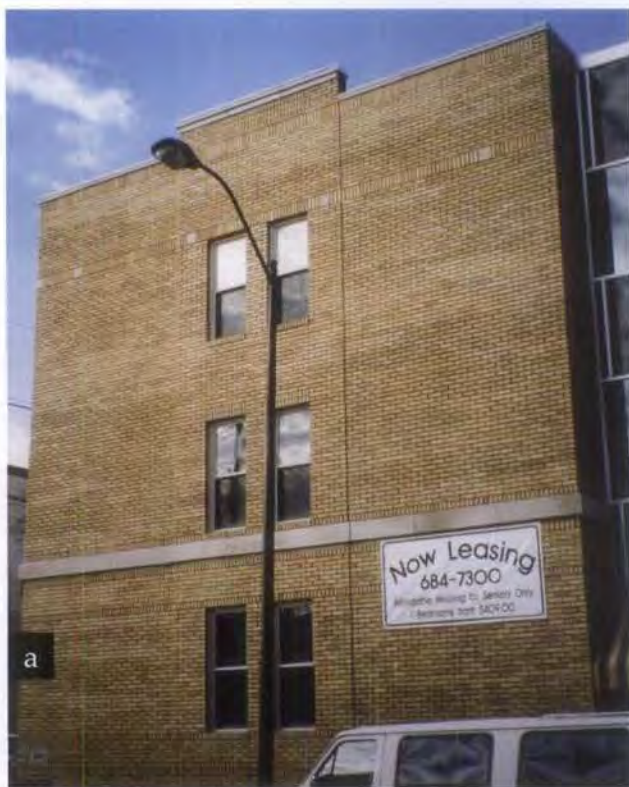
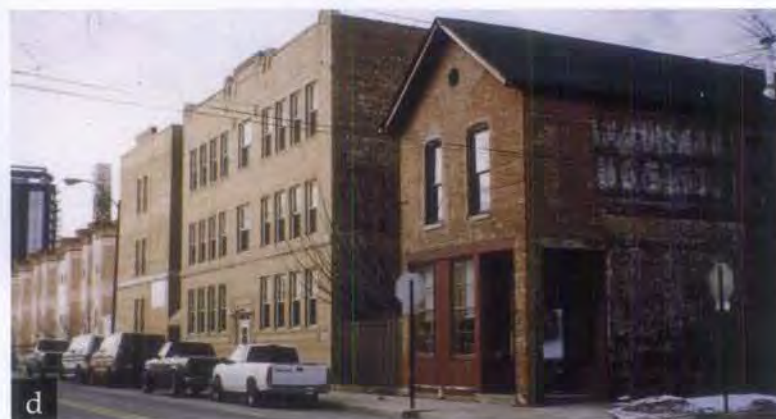
Figure 5. This addition (a) is constructed of matching brick and attached by a recessed connector (b) to the 1914 apartment building (c). The design is compatible and the addition is smaller and subordinate to the historic building (d).

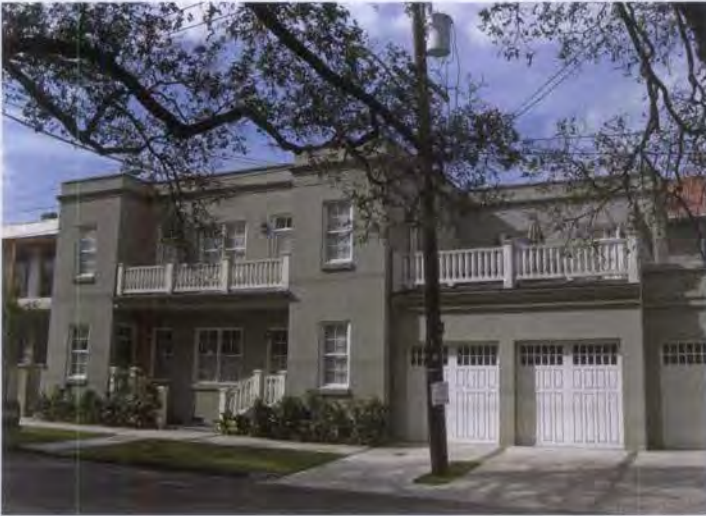
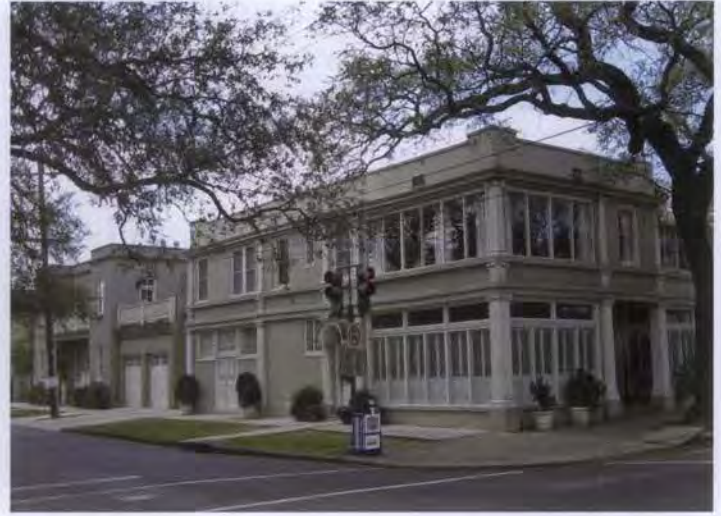
Figure 6. A new addition (left) is connected to the garage which separates it from the main block of the c. 1910 former florist shop (right). The addition is traditional in style, yet sufficiently restrained in design to distinguish it from the historic building.

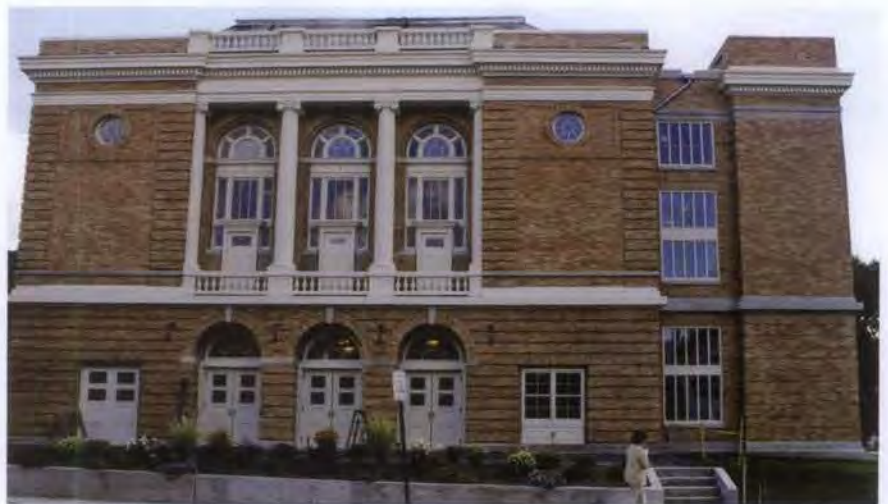
Figure 7. A vacant side lot was the only place a new stair tower could be built when this 1903 theater was rehabilitated as a performing arts center. Constructed with matching materials, the stair tower is set back with a recessed connector and, despite its prominent location, it is clearly subordinate and differentiated from the historic theater.

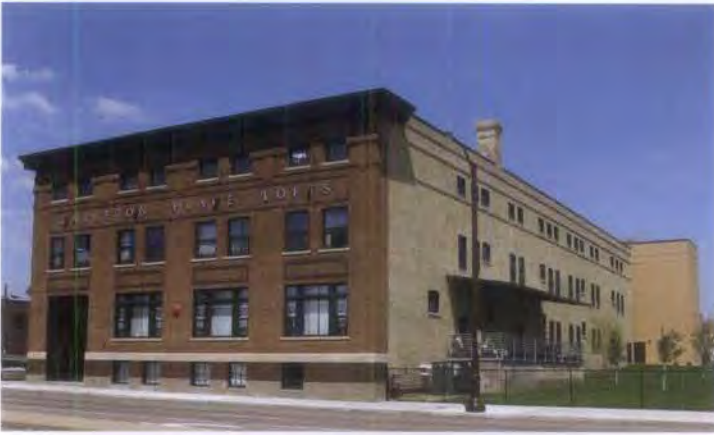
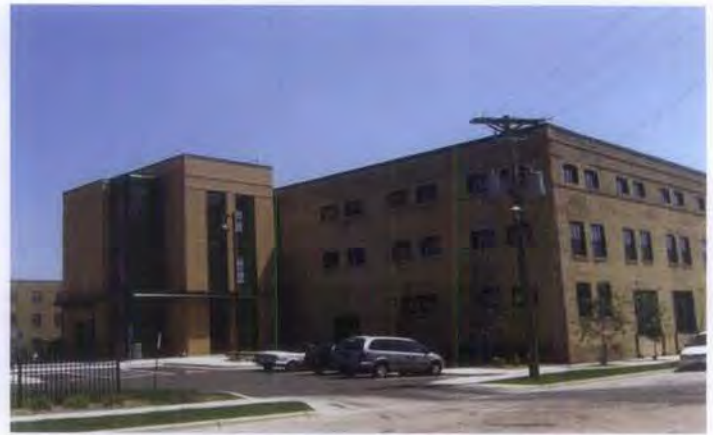
Figure 8. The rehabilitation of this large, early-20th century warehouse (left) into affordable artists' lofts included the addition of a compatible glass and brick elevator/stair tower at the back (right).

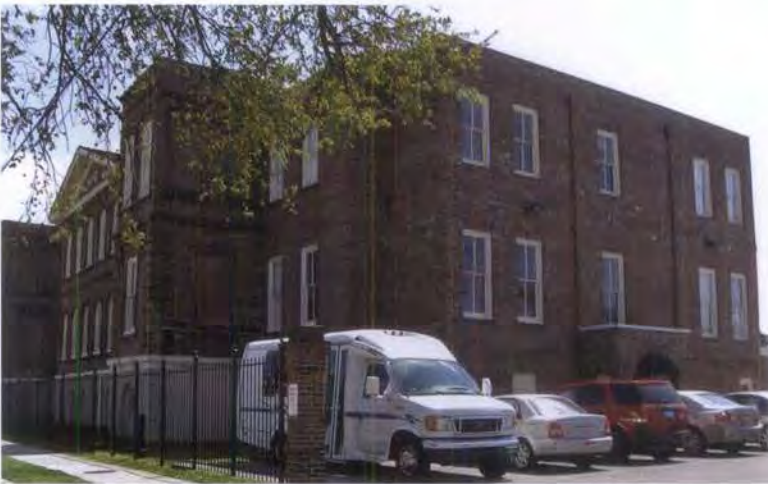
Figure 9. A simple, brick stair tower replaced two non-historic additions at the rear of this 1879 school building when it was rehabilitated as a women's and children's shelter. The addition is set back and it is not visible from the front of the school.

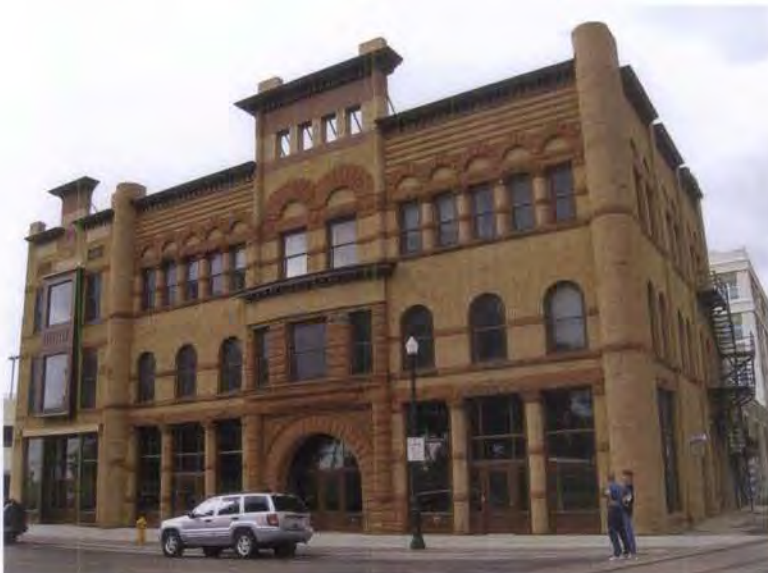
Figure 10. The small size and the use of matching materials ensures that the new addition on the left is compatible with the historic Romanesque Revival-style building.

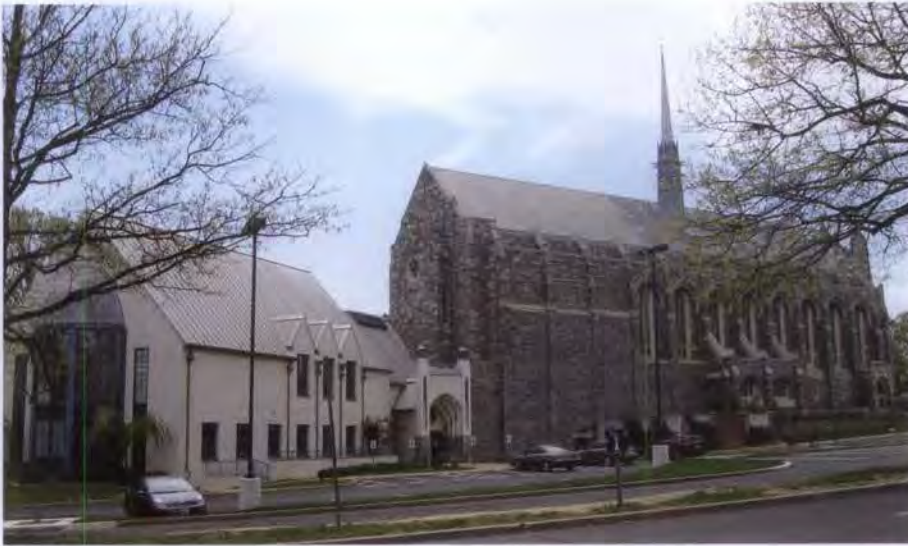
Figure 11. The addition to this early-20th century Gothic Revival-style church provides space for offices, a great hall for gatherings and an accessible entrance (left). The stucco finish, metal roof, narrow gables and the Gothic-arched entrance complement the architecture of the historic church. Placing the addition in back where the ground slopes away ensures that it is subordinate and minimizes its impact on the church (below).

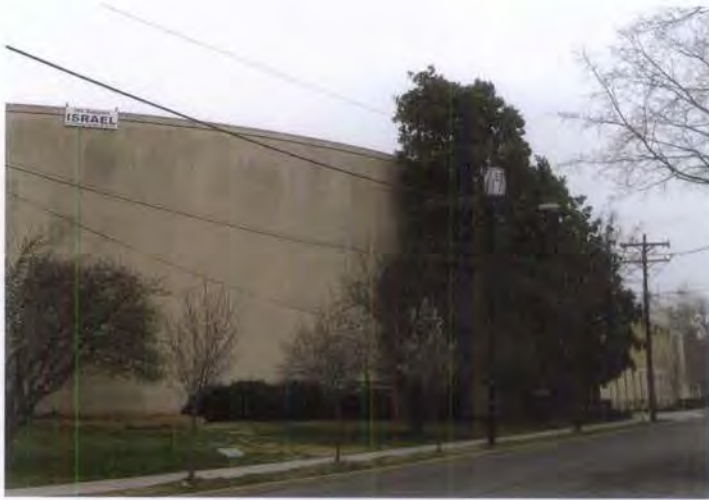
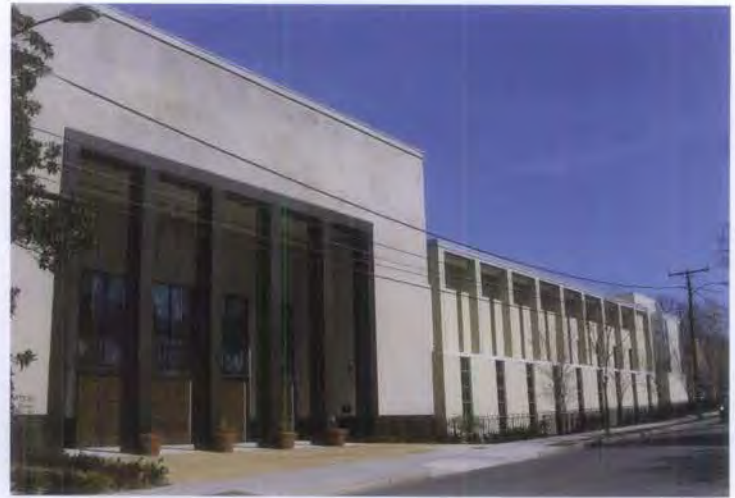
Figure 12. This 1954 synagogue (left) is accessed through a monumental entrance to the right. The new education wing (far right) added to it features the same vertical elements and color and, even though it is quite large, its smaller scale and height ensure that it is secondary to the historic resource.

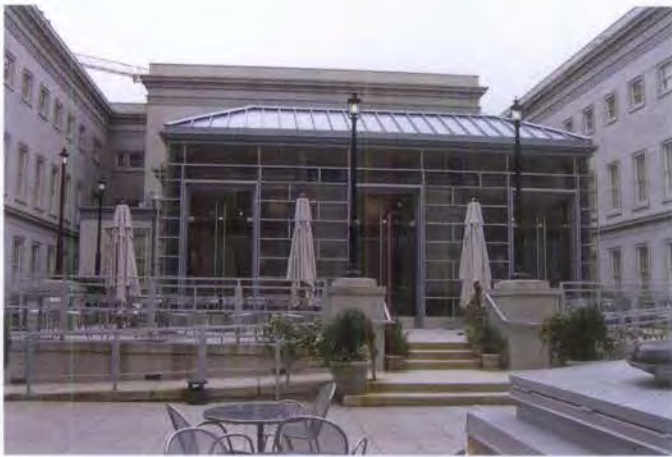
Figure 13. A glass and metal structure was constructed in the courtyard as a restaurant when this 1839 building was converted to a hotel. Although such an addition might not be appropriate in a more public location, it is compatible here in the courtyard of this historic building.
