WENATCHEE HISTORIC PRESERVATION BOARD
REGULAR MEETING
June 7, 2023

- V. **NEW BUSINESS**
 - A. Review of Parliamentary Procedure – staff presentation (30 minutes)
 - B. Workshop – Fuller-Quigg Façade Updates (30 minutes)

RESTORATIONS TO BRING A COHESIVE OVERALL DESIGN

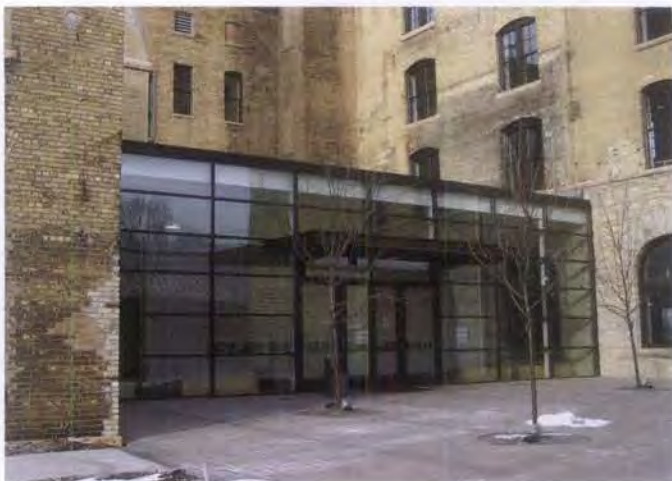
Figure 14. This glass addition was erected at the back of an 1895 former brewery during rehabilitation to provide another entrance. The addition is compatible with the plain character of this secondary elevation.

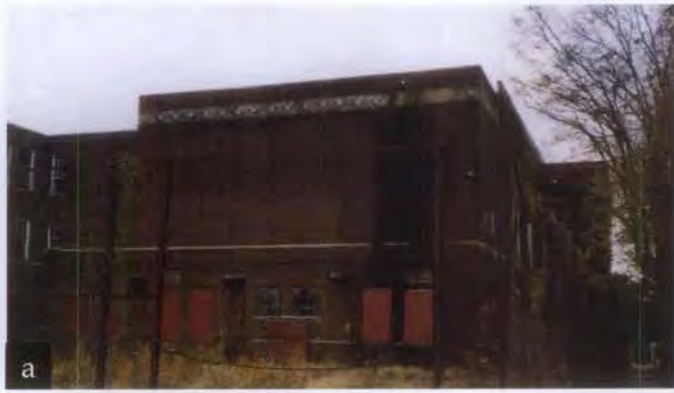
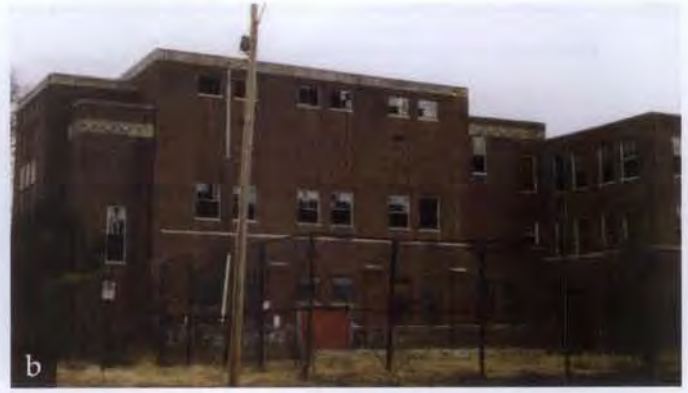
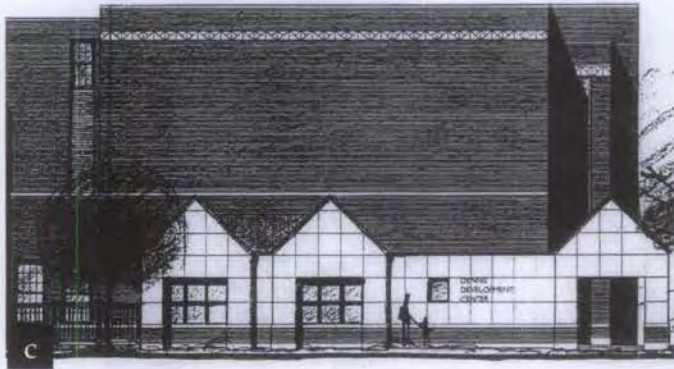
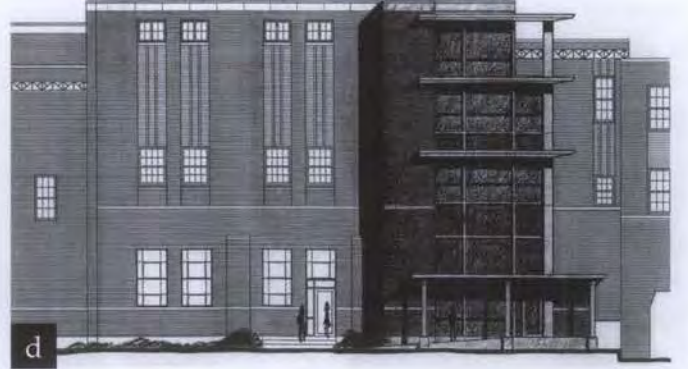
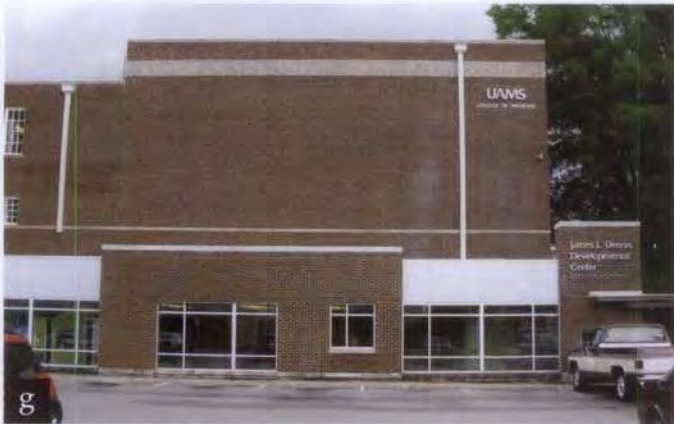
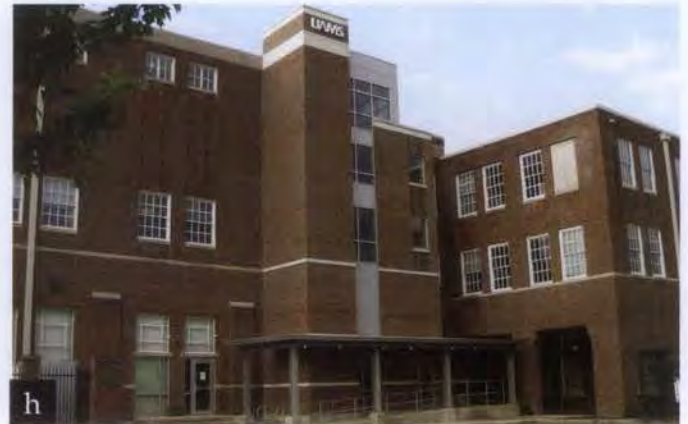
Figure 15. The rehabilitation of a c. 1930 high school auditorium for a clinic and offices proposed two additions: a one-story entrance and reception area on this elevation (a); and a four-story elevator and stair tower on another side (b). The gabled entrance (c) first proposed was not compatible with the flat-roofed auditorium and the design of the proposed stair tower (d) was also incompatible and overwhelmed the historic building. The designs were revised (e-f) resulting in new additions that meet the Standards (g-h).

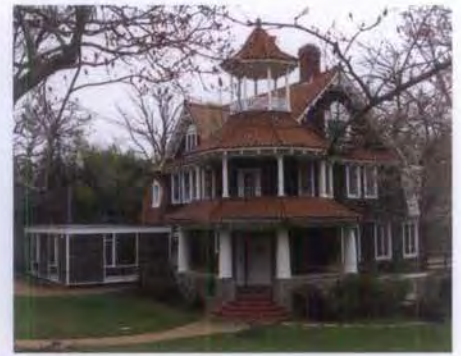
Figure 17. The small addition on the left is starkly different and it is not compatible with the eclectic, late-19th century house.

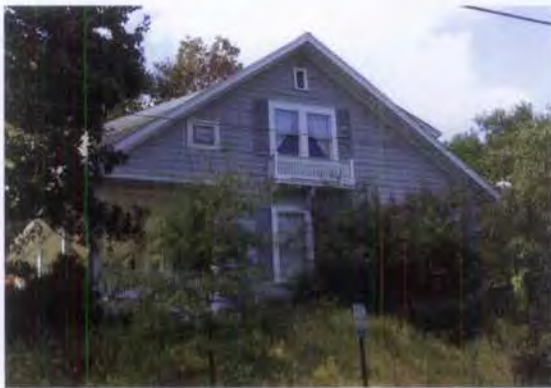
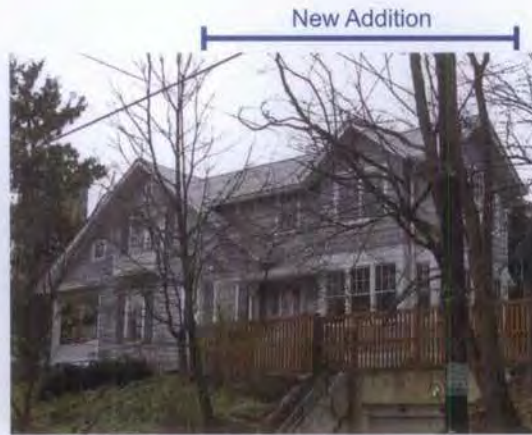
Figure 18. The expansion of a one- and one-half story historic bungalow (left) with a large two-story rear addition (right) has greatly altered and obscured its distinctive shape and form.

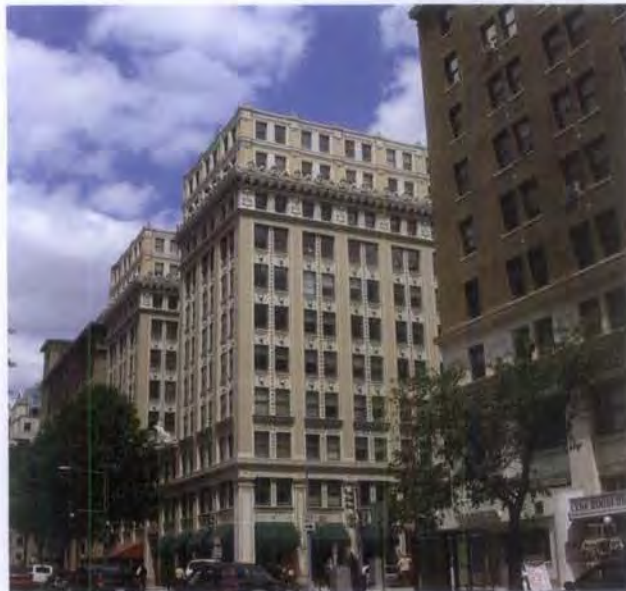
Figure 19. The upper two floors of this early-20th century office building were part of the original design, but were not built. During rehabilitation, the two stories were finally constructed. This treatment does not meet the Standards because the addition has given the building an appearance it never had historically.

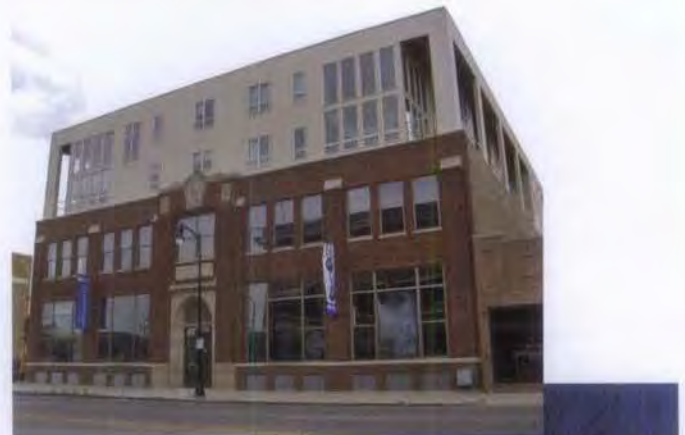
Figure 20. The height, as well as the design, of these two-story rooftop additions overwhelms the two-story and the one-story, low-rise historic buildings.

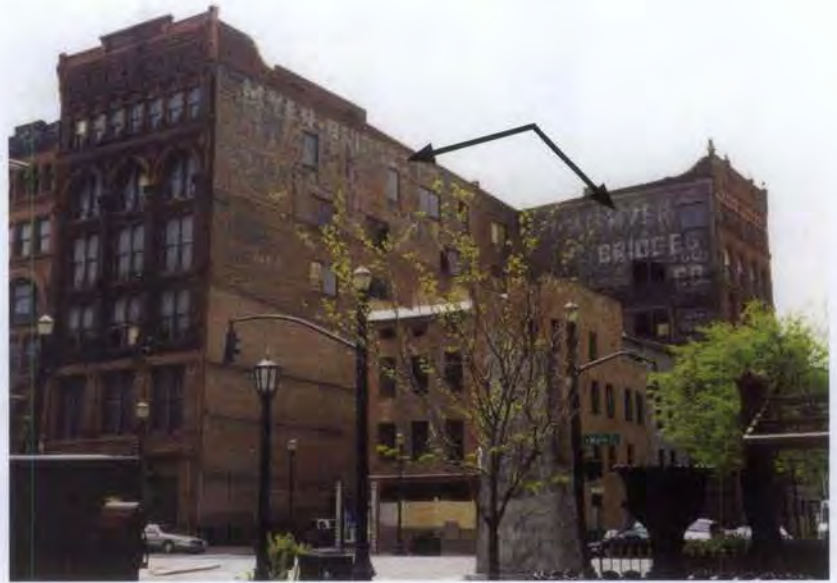
Figure 21. Both wings of this historic L-shaped building (top), which fronts on two city streets, adjoined vacant lots. A two-story addition was constructed on one lot (above, left) and a six-story addition was built on the other (above, right). Like the historic building, which has two different facades, the compatible new additions are also different and appear to be separate structures rather than part of the historic building.

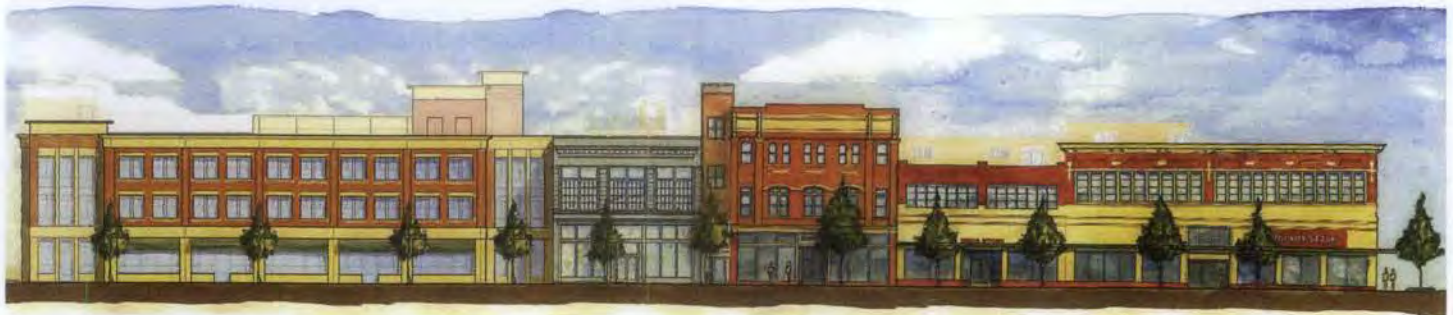
Figure 22. The proposed new addition is compatible with the historic buildings that remain on the block. Its design with multiple storefronts helps break up the mass.

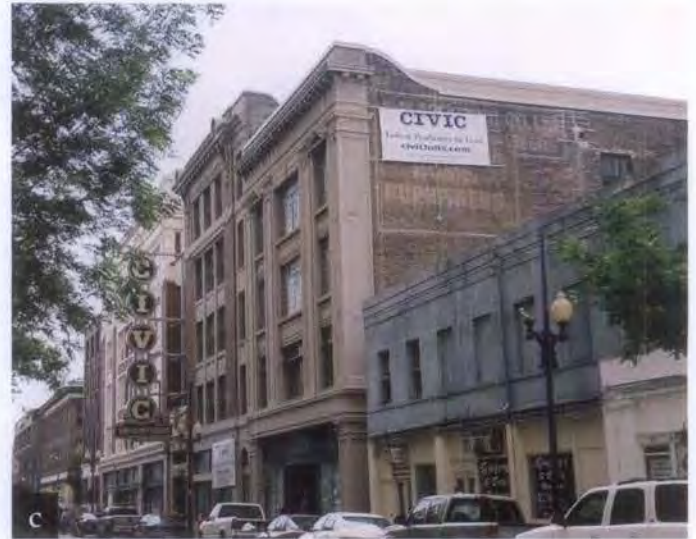
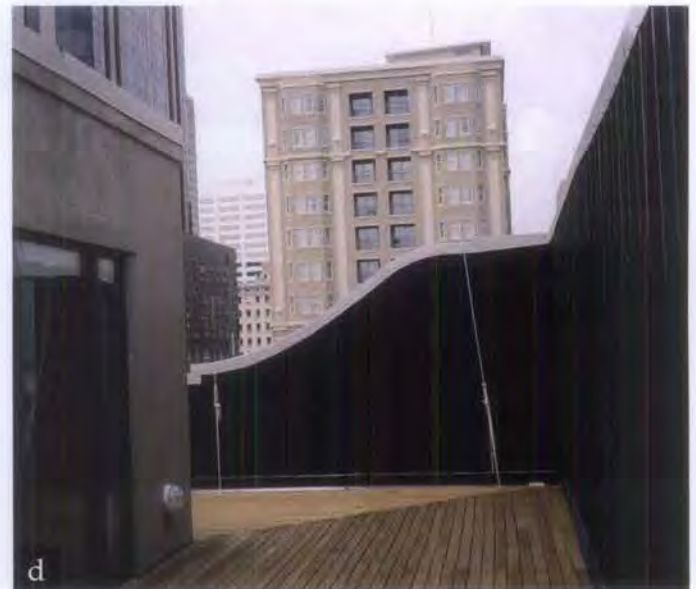
Figure 23. Colored flags marking the location of a proposed penthouse addition (a) were placed on the roof to help evaluate the impact and visibility of an addition planned for this historic furniture store (b). Based on this evaluation, the addition was constructed as proposed. It is minimally visible and compatible with the 1912 structure (c). The tall parapet wall conceals the addition from the street below (d).

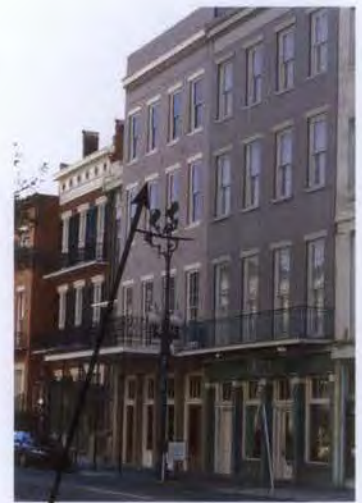
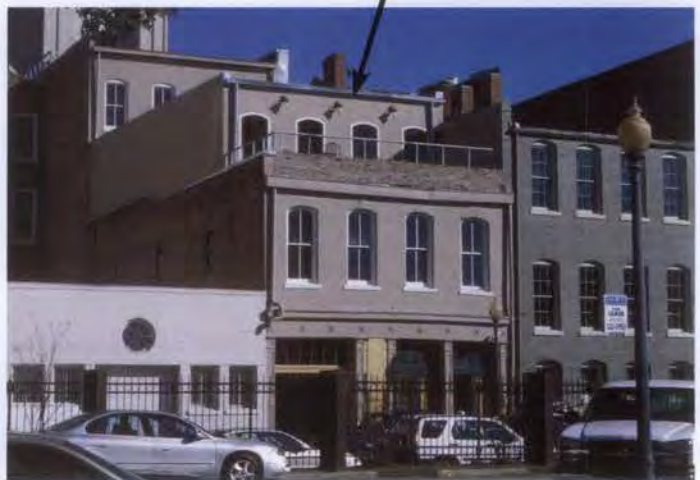
Figure 26. A rooftop addition would have negatively impacted the character of the primary facade (right) of this mid-19th century, four-story structure and the low-rise historic district. However, a third floor was successfully added on the two-story rear portion (below) of the same building with little impact to the building or the district because it blends in with the height of the adjacent building.

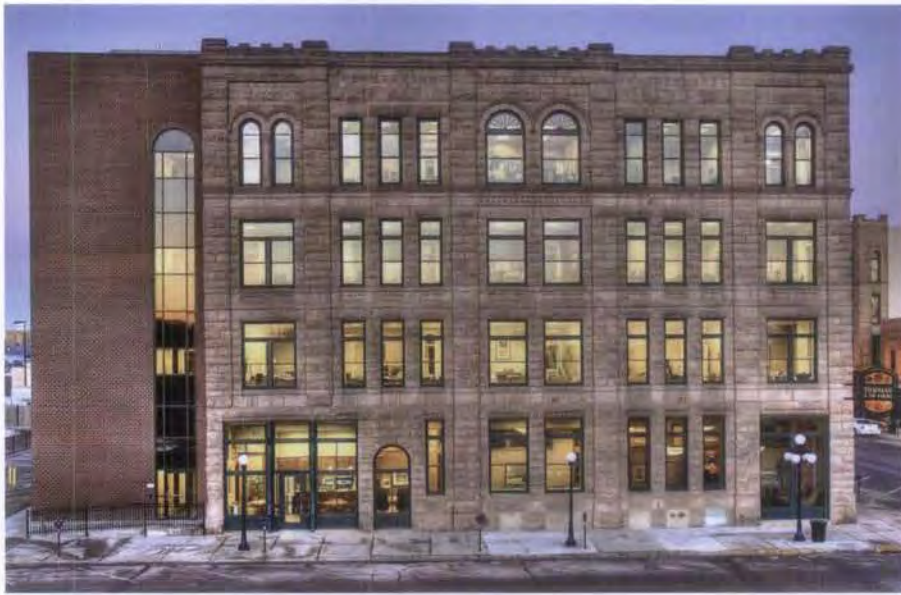
Figure 27. Although the new brick stair/elevator tower (left) is not visible from the front (right), it is on a prominent side elevation of this 1890 stone bank. The compatible addition is set back and does not compete with the historic building. Photos: Chadd Gossmann, Aurora Photography, LLC.

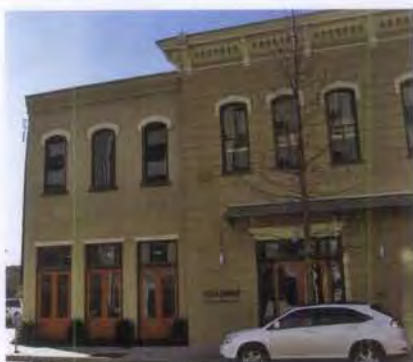
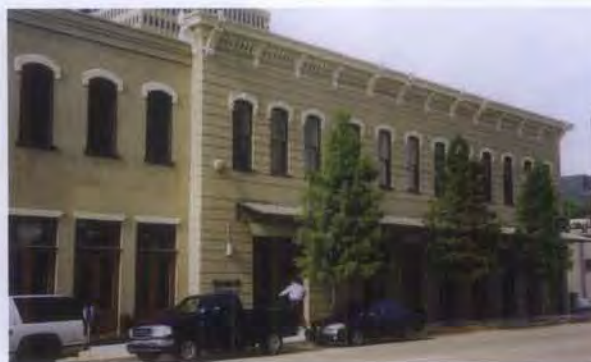
Figure 28. A small addition (left) was constructed when this 1880s train station was converted for office use. The paired doors with transoms and arched windows on the compatible addition reflect, but do not replicate, the historic building (right).

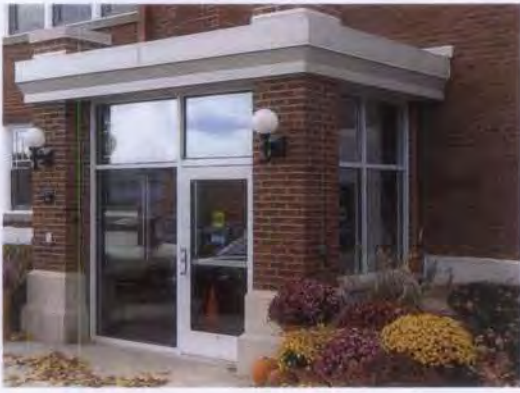
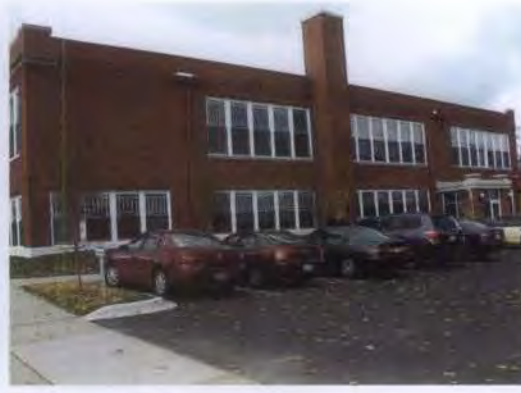
Figure 29. This simple glass and brick entrance (left) added to a secondary elevation of a 1920s school building (right) is compatible with the original structure.

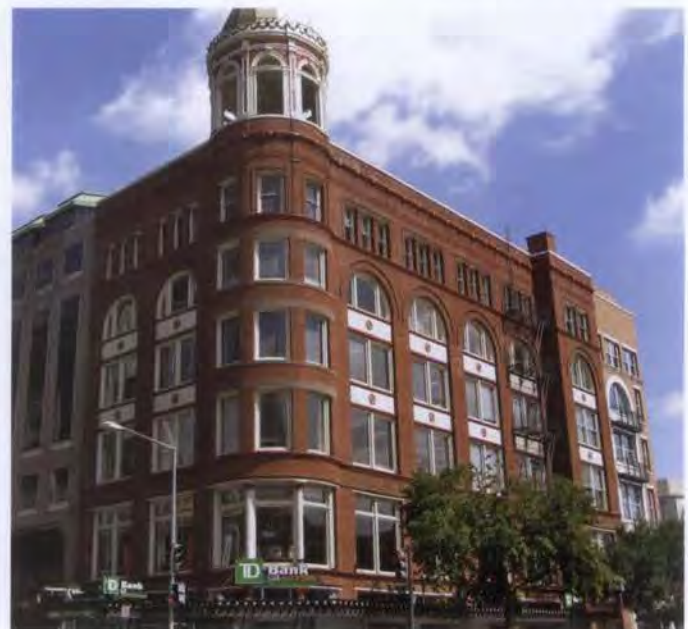
Figure 30. The small addition on the right of this late-19th century commercial structure is clearly secondary and compatible in size, materials and design with the historic building.

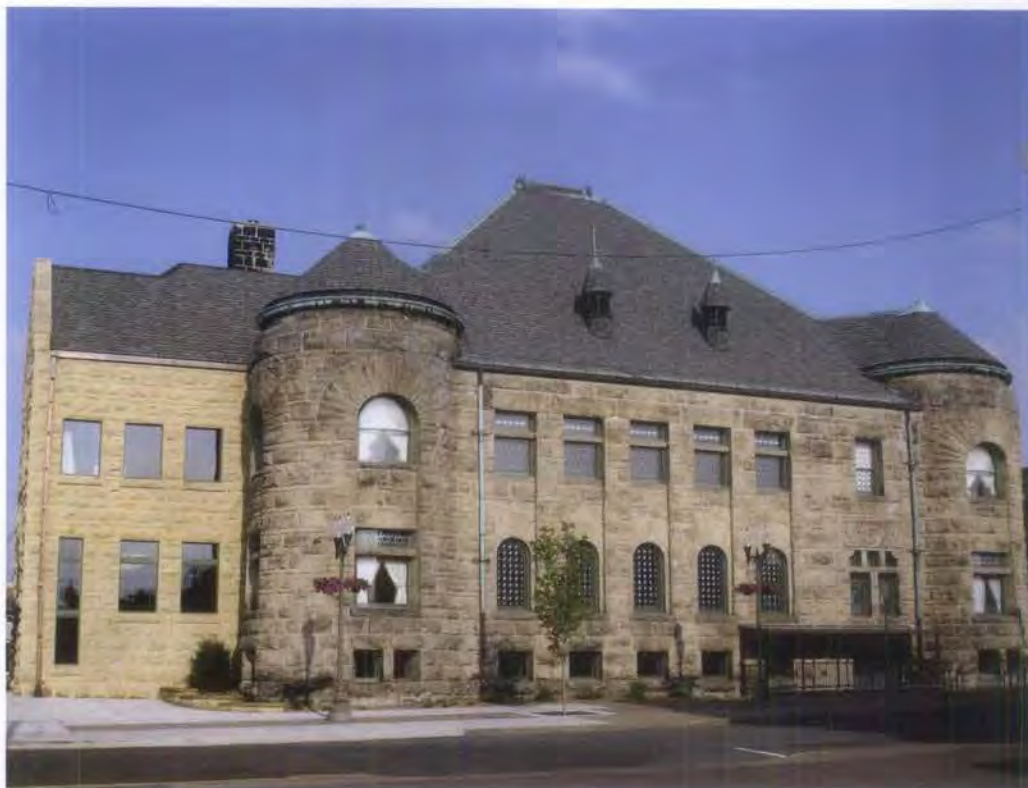
Figure 31. An elevator/stair tower was added at the back of this Richardsonian Romanesque-style theater when it was rehabilitated. Rough-cut stone and simple cut-out openings ensure that the addition is compatible and subordinate to the historic building. Photo: Chuck Liddy, AIA.
