WENATCHEE HISTORIC PRESERVATION BOARD
REGULAR MEETING
August 2, 2023

Description of Request: This is an application for a Certificate of Appropriateness submitted by Spencer Howard, Northwest Vernacular, Inc., representative for the property owner, Michael Fleming, Wenatchee S & L, LLC. The proposal is to replace the windows and sash on the 2nd through 4th floors on all the facades. The building is listed on the Wenatchee Register of Historic Places. Application materials are included as Attachment A.

Project description: The proposal is to replace the windows and sash on the 2nd through 4th floors on all the facades. A detailed narrative and architectural drawings are provided as a part of Attachment A.

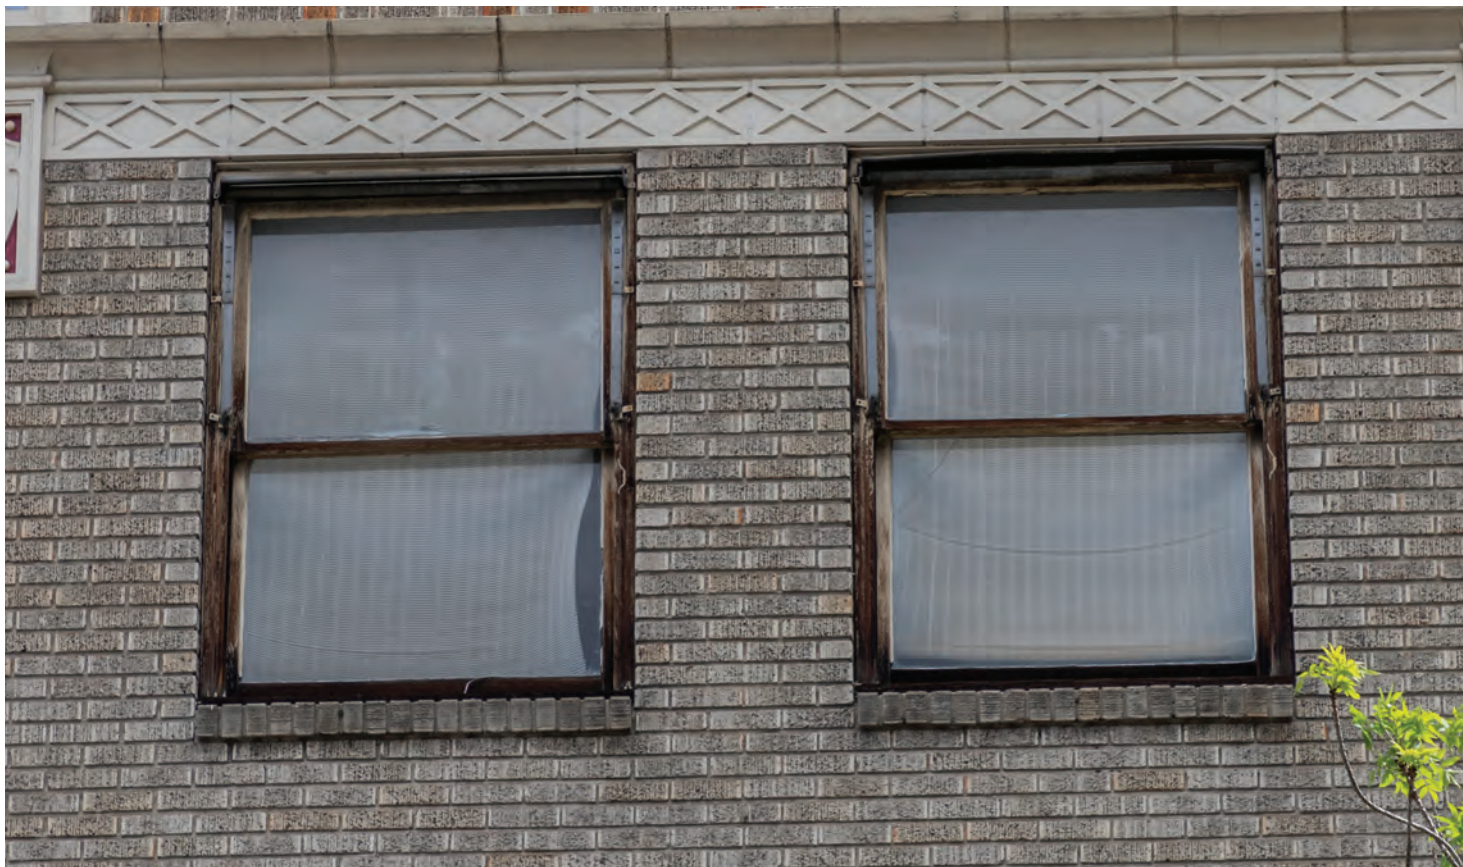
Fig. 4. West facade, fourth story, north windows, showing wood window conditions.

- **1:1 wood sashes**, painted, original with original glass. Existing wood sashes are not mahogany, but Douglas fir or similar. Replace with new retrofit sash system. Maintenance ceased under previous ownership as sashes were replaced with anodized aluminum and then selectively with vinyl. Remaining wood sash exhibit deterioration due to paint loss and wood exposure to wetting and drying cycles (rain/sun).

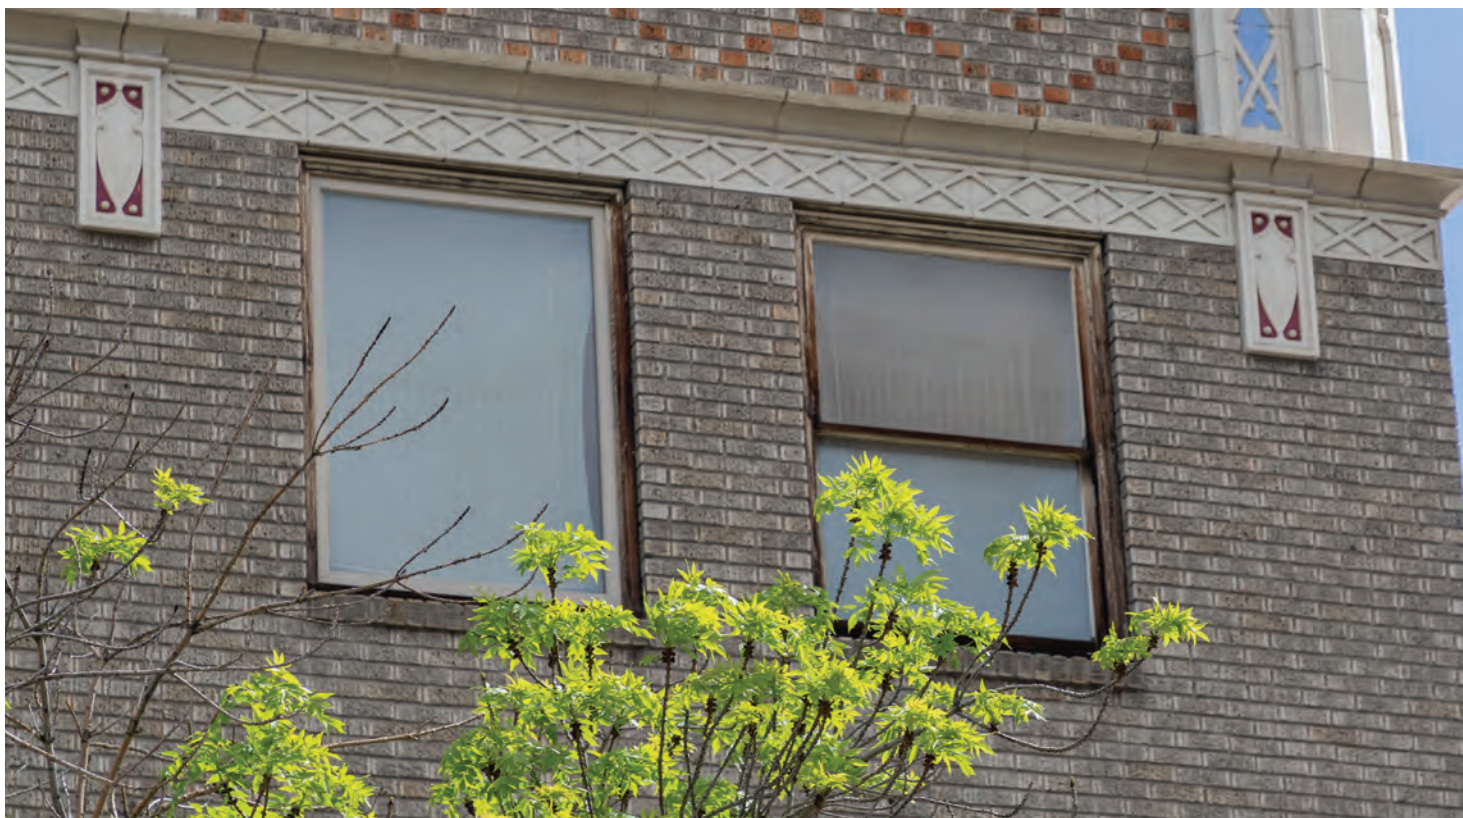
Fig. 5. West facade, fourth story, south windows, showing a replacement window and wood window conditions.

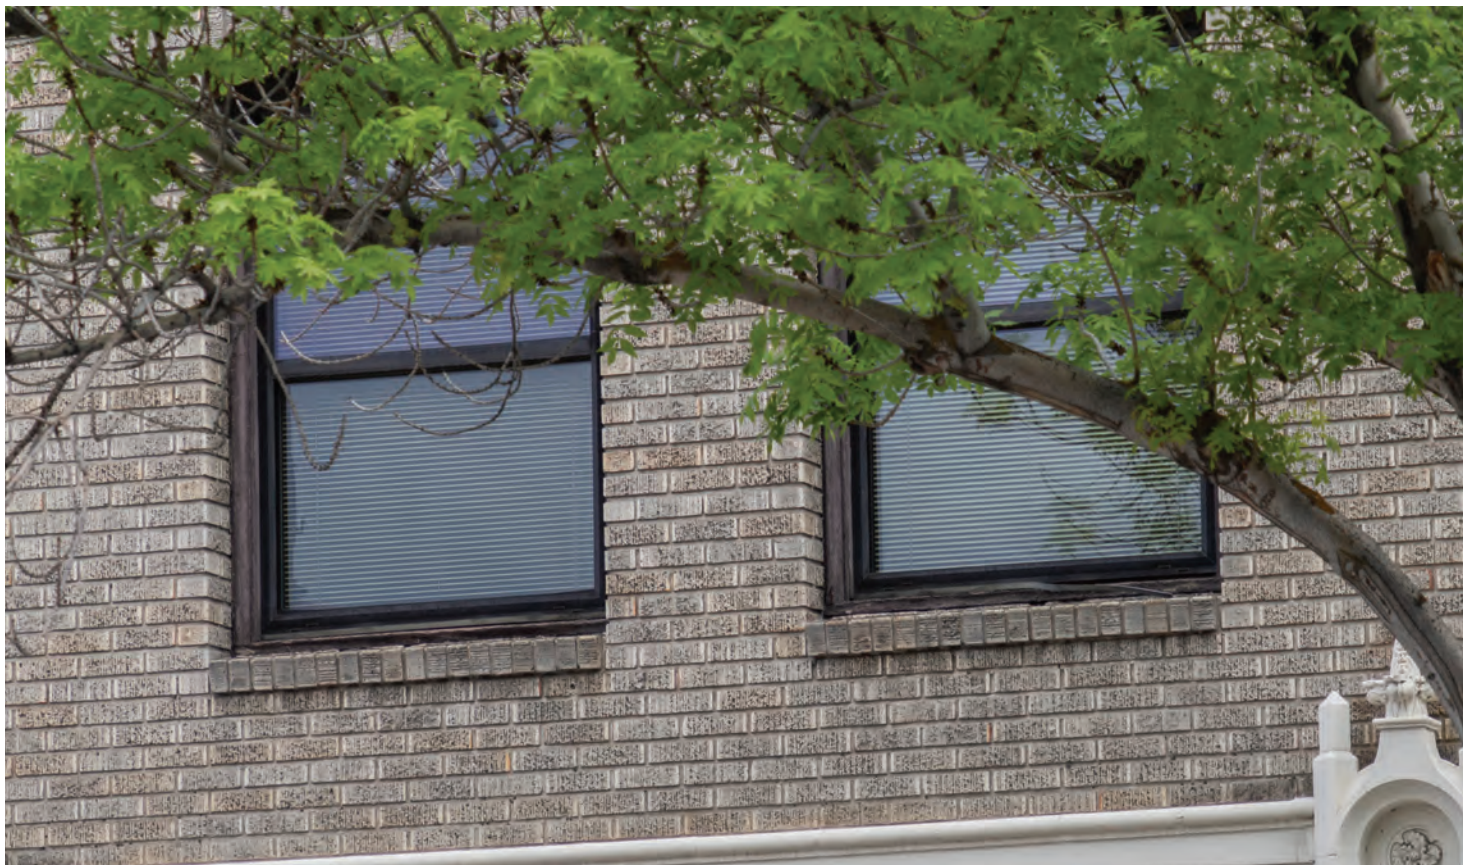
Fig. 6. West facade, second story, north windows, showing conditions of previous replacement windows.

- **Vinyl and anodized aluminum sashes** installed by previous owners with insulated glazing units. Not historic. Replace with new retrofit sash system (see below). Seals are failing. The sashes are not compatible with the original sash.

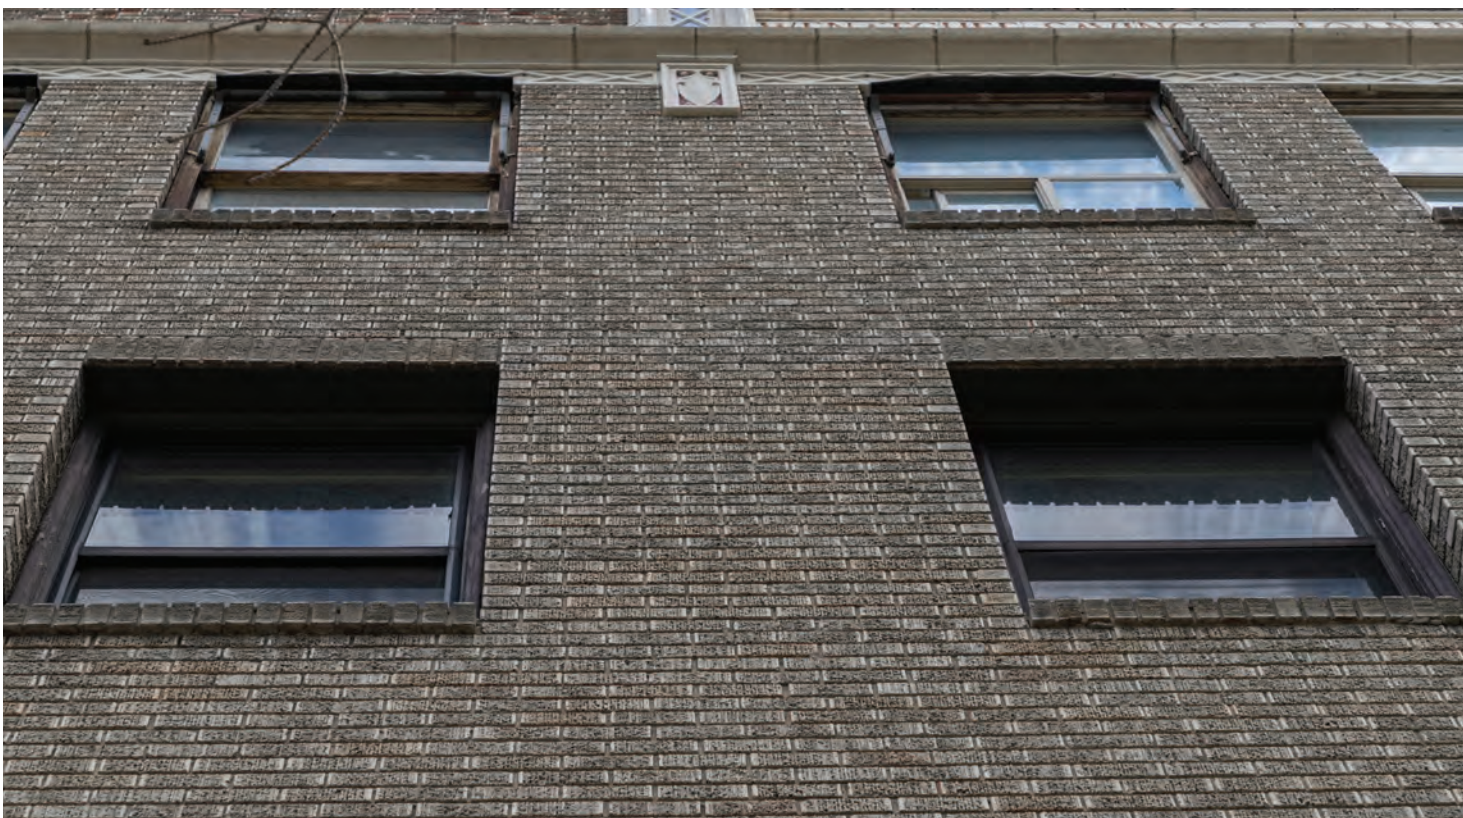
Fig. 7. West facade, looking up from the sidewalk showing window headers and window conditions.

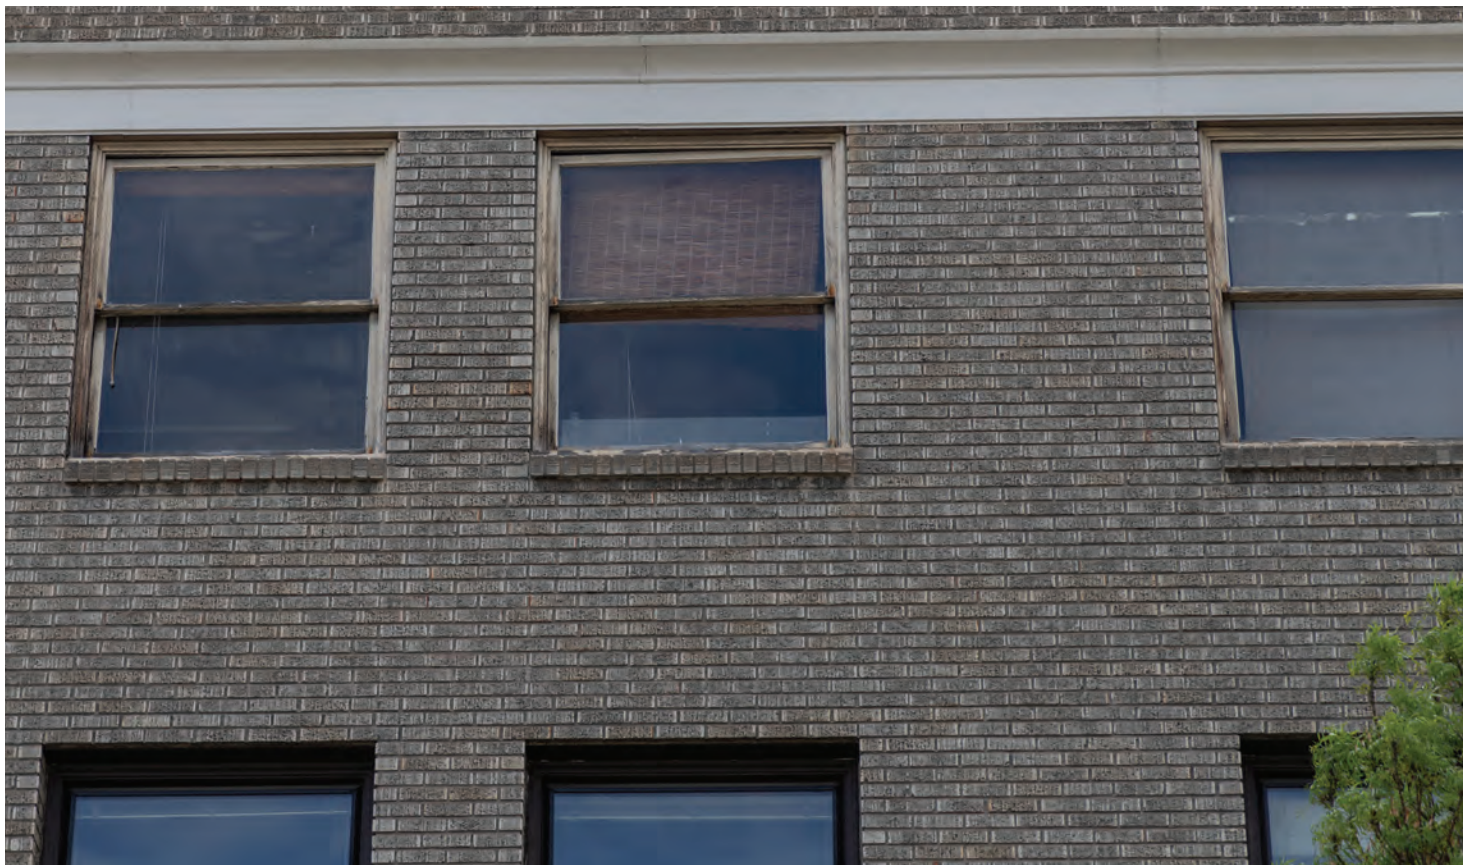
Fig. 9. North facade, east portion, fourth story windows showing wood window conditions.

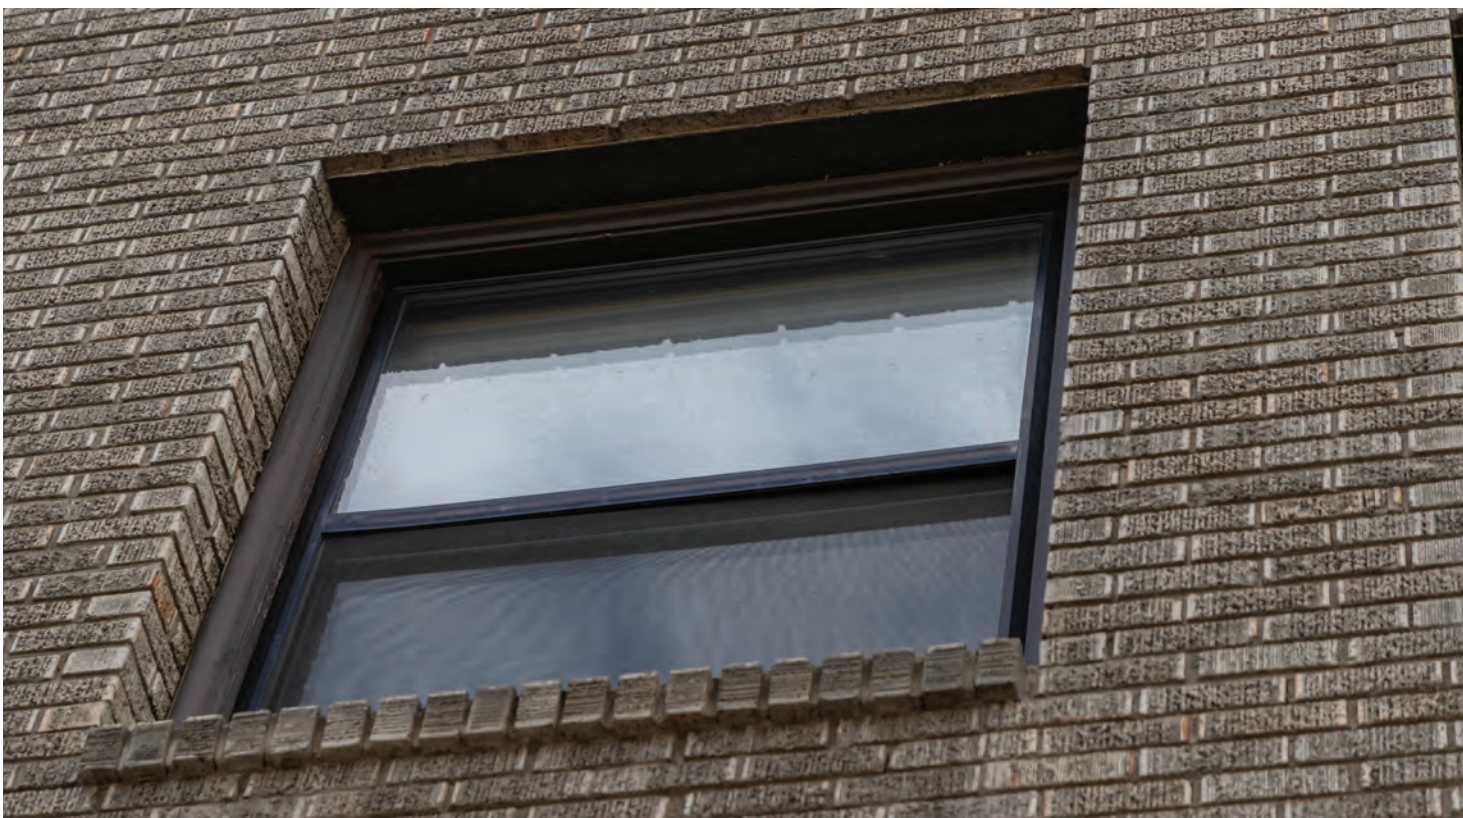
Fig. 10. North facade, east portion, third story, showing previous replacement window conditions.

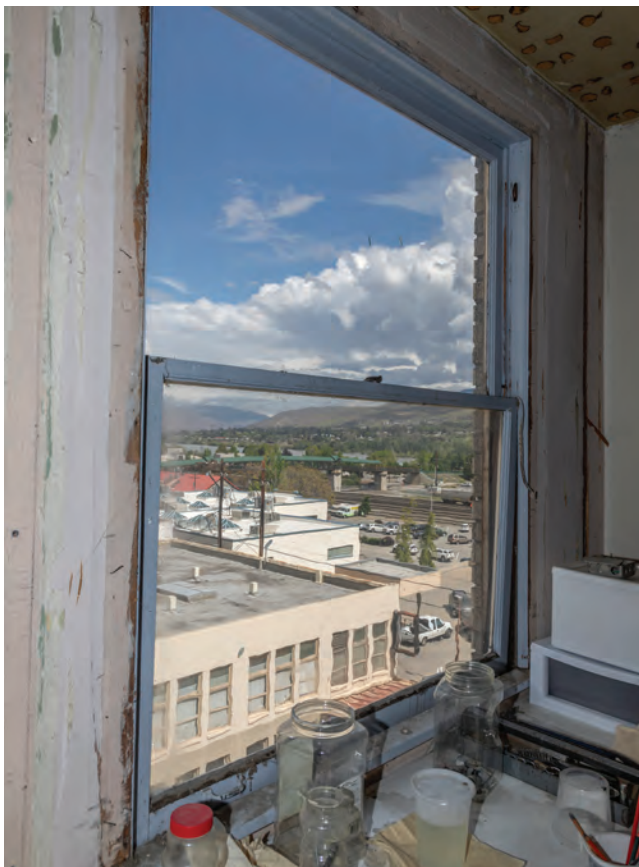
Fig. 11. North facade, fourth floor, west portion, interior detail showing typical configuration and conditions.

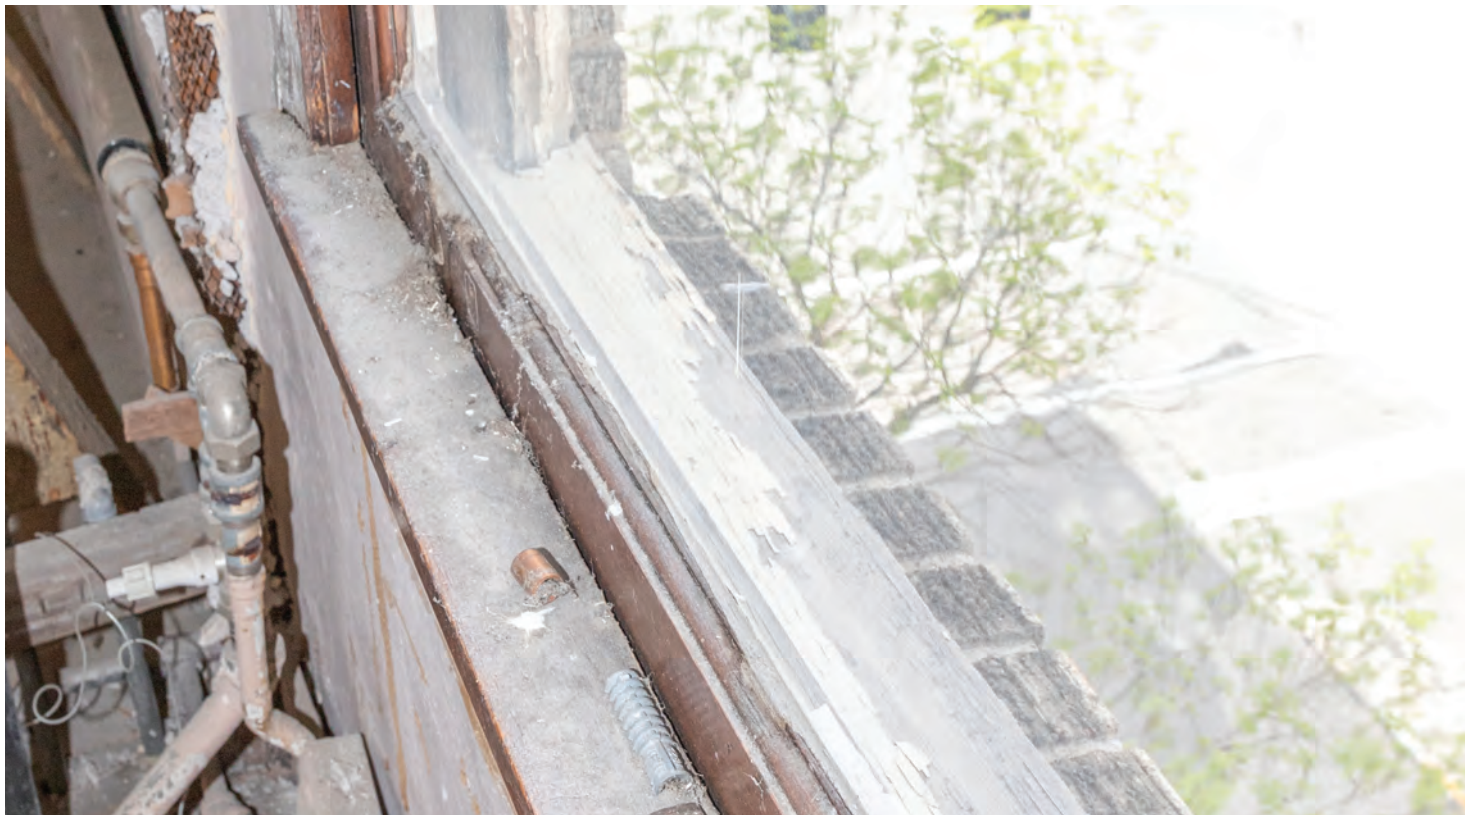
Fig. 12. North facade, fourth floor, interior detail showing exterior sill configuration and condition.

- Wood slip sills**, wood, painted, original. On east, north, and west facades, and south facade outside of the light well. Retain in place. Epoxy consolidate as needed. Repaint to protect wood. Fabricate, paint (to match new retrofit sash system paint color), and install sheet metal flashing pans for window sills. Caulk edge transitions at brick. Caulk color to match new retrofit sash system paint color. Wood sills exhibit significant material deterioration, and material (due to weathering) and paint loss. The metal pan flashings retain sills in place without having to take apart the full exterior window assembly (brick moldings, frame, sill). They provide a minimally to non visible surface with a high long-term durability to protect the wall system from water infiltration.

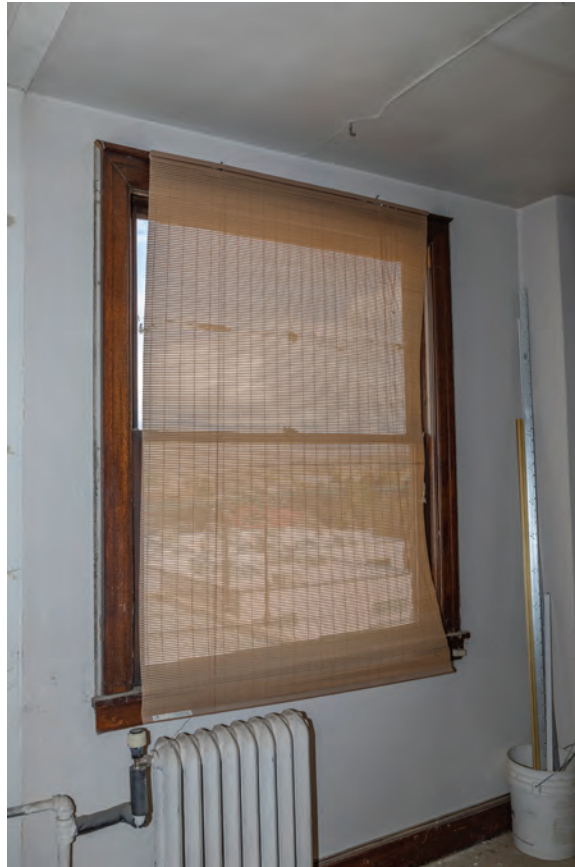
Fig. 13. North facade, fourth floor, view showing original stained wood trim, stool, and apron. Blinds are added.

- Trim, original.** Stained mahogany, stepped profile, mitered corners, with a raised outer band with decorative molded edge. Alterations include previous painting of some trim (mostly at the fourth floor) and removal of some. Retain in place. In-kind replacement flat stock where missing, matching stepped profile. Use off the shelf if can find a match, or mill to match. Raised corner band replacements where missing to be square stock unless a matching or compatible off-the-shelf molding stock can be located. At surrounds where trim boards are stained mahogany, or where all boards are missing, utilize mahogany, matching finish. At surrounds where the window assembly has been painted (trim boards, stops, stool, apron) utilize paint grade molding stock. Paint, match paint color existing window trim at each location.

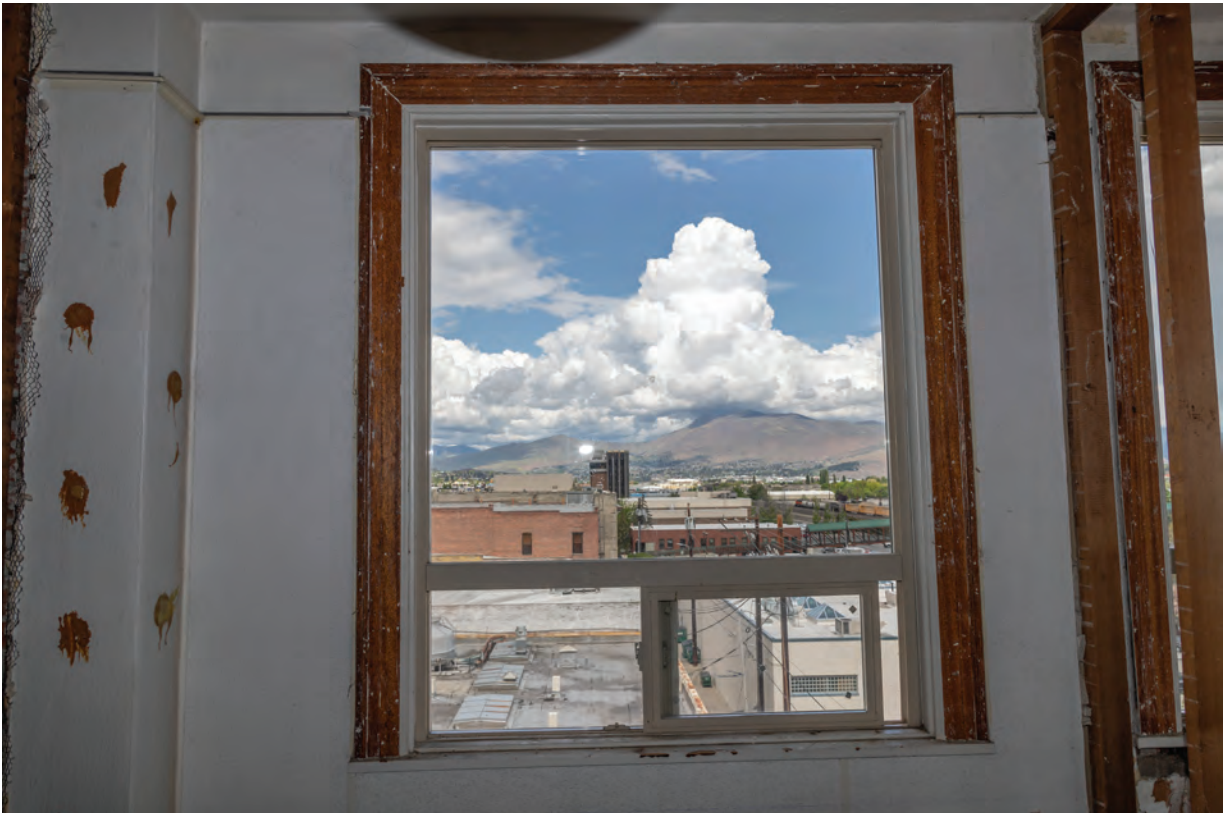
Fig. 14. North facade, fourth floor, view showing a previous replacement window, window trim painted with some areas partially stripped, and a missing apron.

- Trim, previous additions.** Not historic. Painted wood, mitered corners, narrow with a rounded profile. Added by previous owners at some openings, mostly at the fourth floor. Remove. Install new trim matching original profile. See Trim, original above for details on stained versus painted window assemblies.

- **Aprons, previous additions.** Not historic. Painted wood, narrow with a rounded profile. Occur mostly at the fourth floor. Added by previous owners at some openings. Remove. Install new aprons matching original profile. See Trim, original above for details on stained versus painted window assemblies.
- **Sash chords, pulleys, and weights.** Cotton rope, metal pulleys (sheaves and plates) and weights, original. Most of the rope has been removed due to previous alterations. Remove pulley sheaves and remaining ropes. Retain pulley plates and weights in weight pockets.
- **Sash lifts, original.** Metal, two per lower sash at bottom rail. Remain only at some original fourth floor windows. Remove.
- **Sash latch, original.** Metal, one at meeting rail. Remain only at some original fourth floor windows. Remove.
- **Window treatments.** Not historic. Venetian blind additions. Remove.

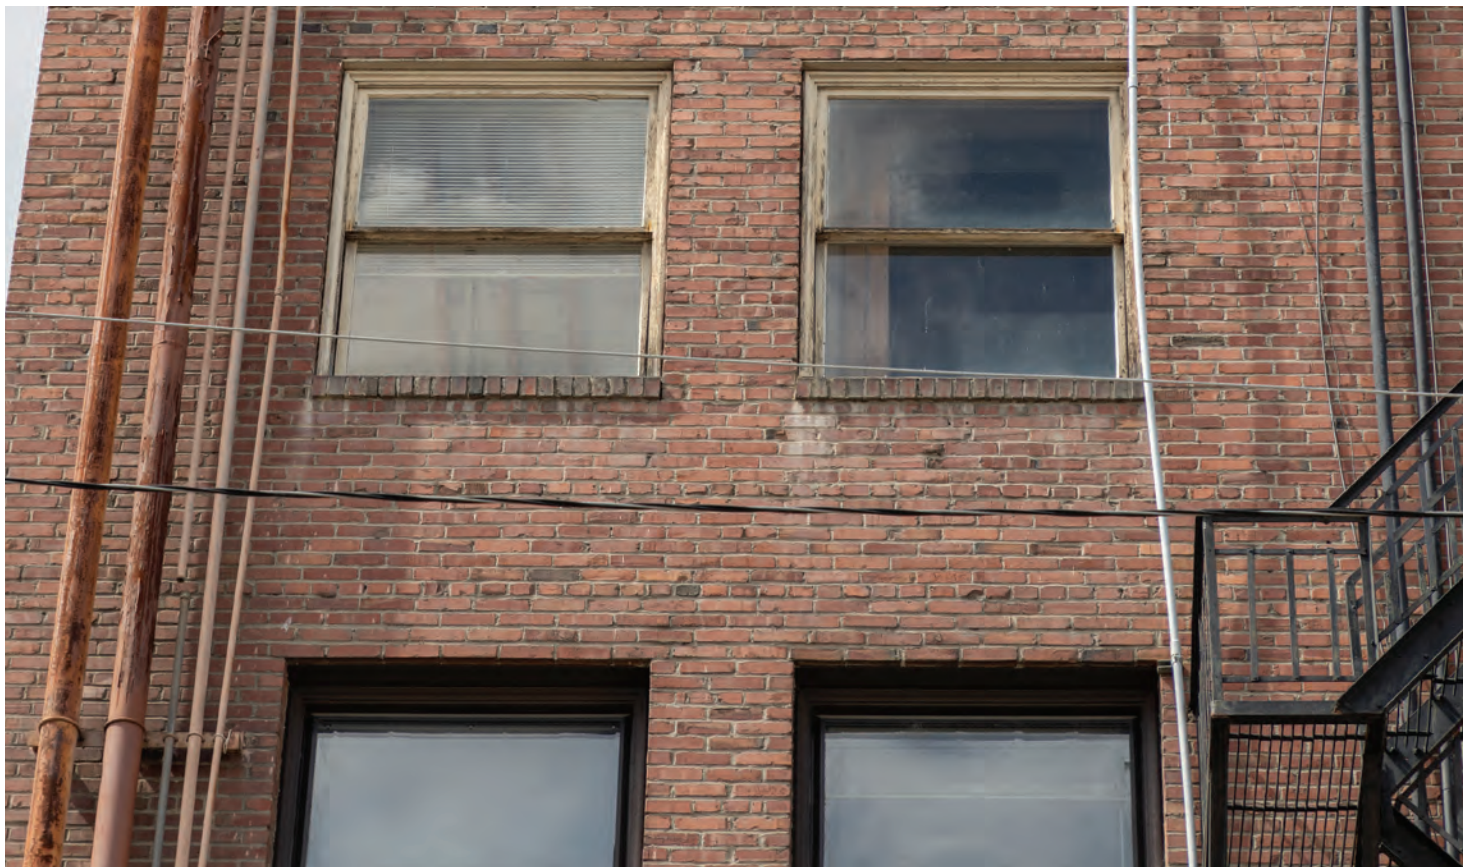
Fig. 16. East facade, south portion, third (partial) and fourth story windows showing existing conditions.

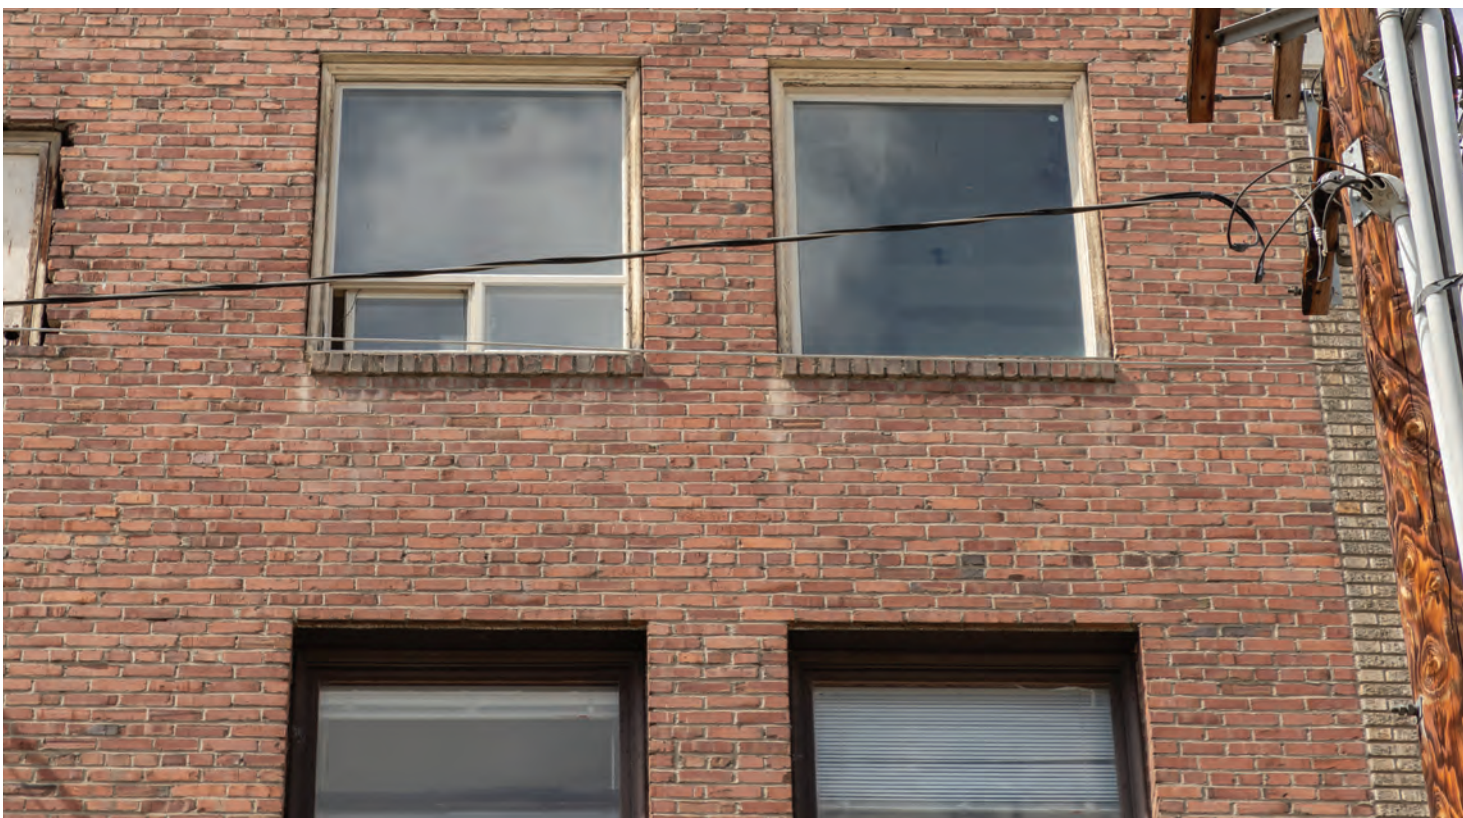
Fig. 17. East facade, north portion, third (partial) and fourth story windows showing existing conditions.

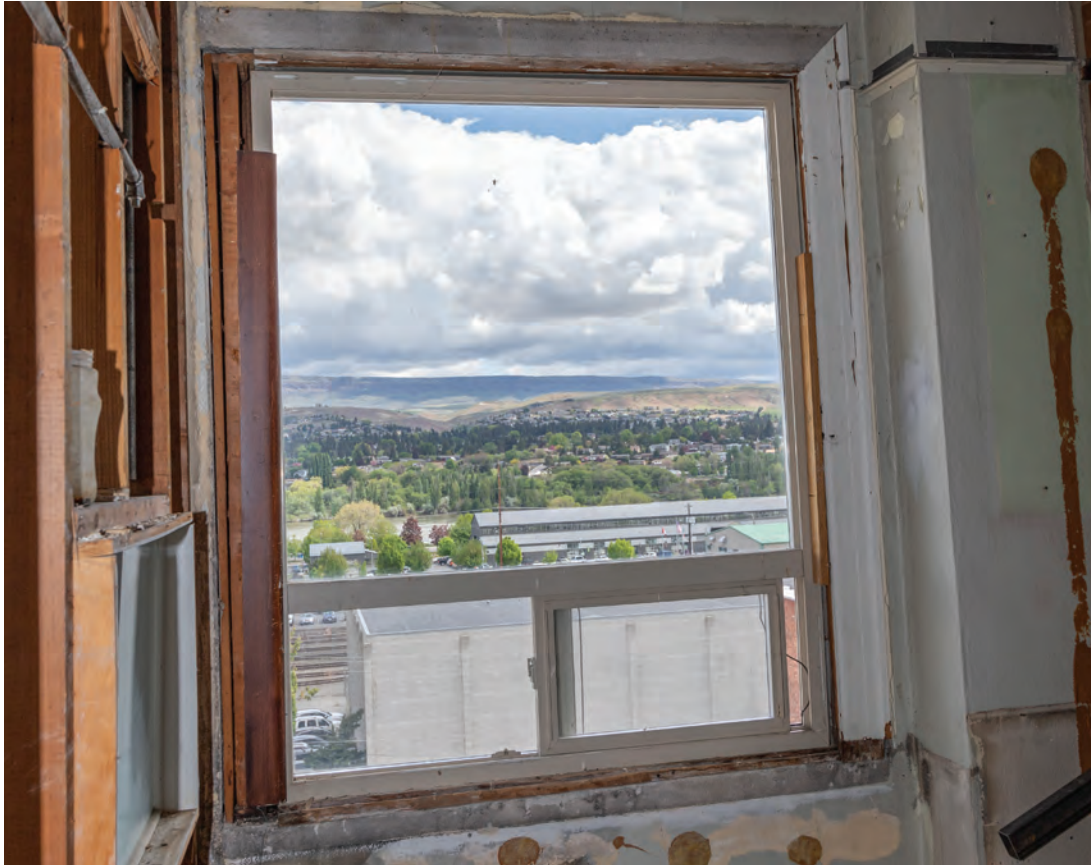
Fig. 18. East facade, north portion, fourth floor, showing remnant trim at a replacement window.

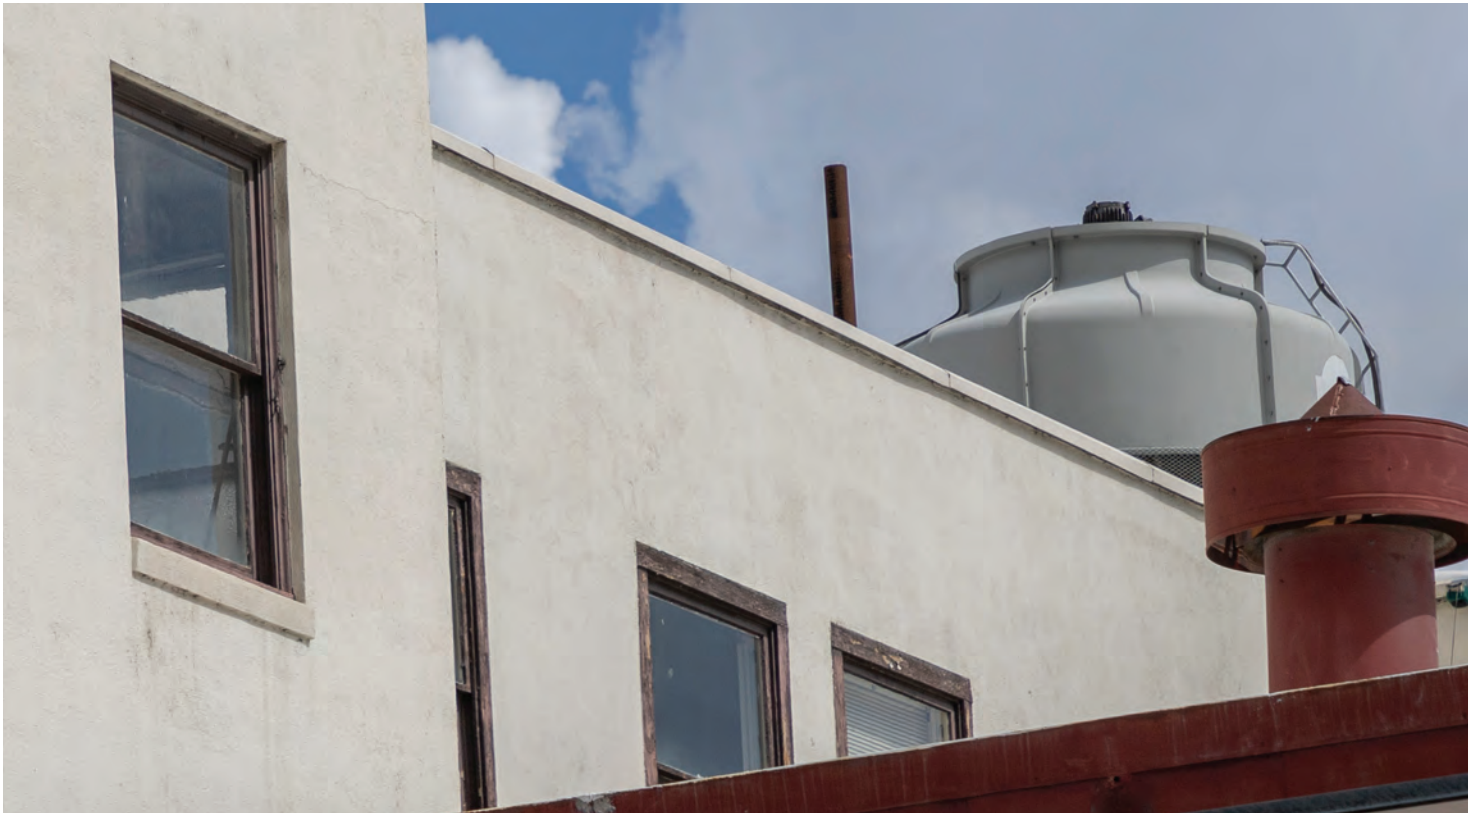
Fig. 19. South facade, west portion, fourth story, showing window conditions.

- **Hopper, wood sashes**, painted, original with original glass. Existing wood sashes are not mahogany, but Douglas fir or similar. Replace with new retrofit sash system using a fixed single sash. Remaining wood sash exhibit deterioration due to paint loss and wood exposure to wetting and drying cycles on the south facade.

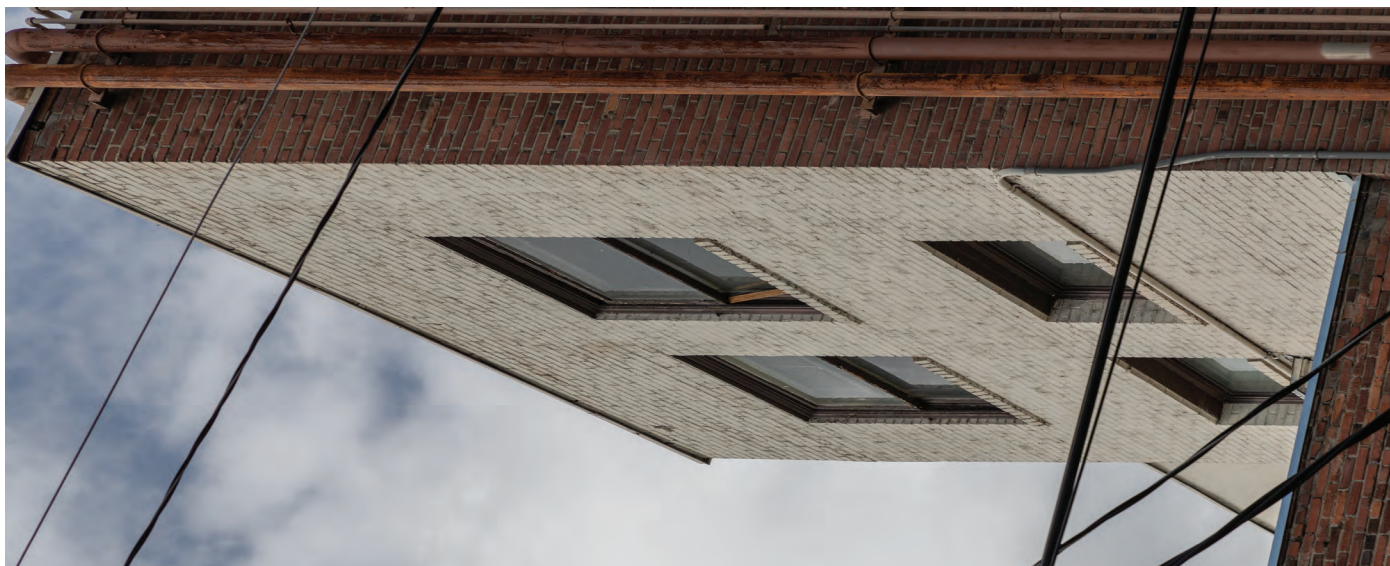
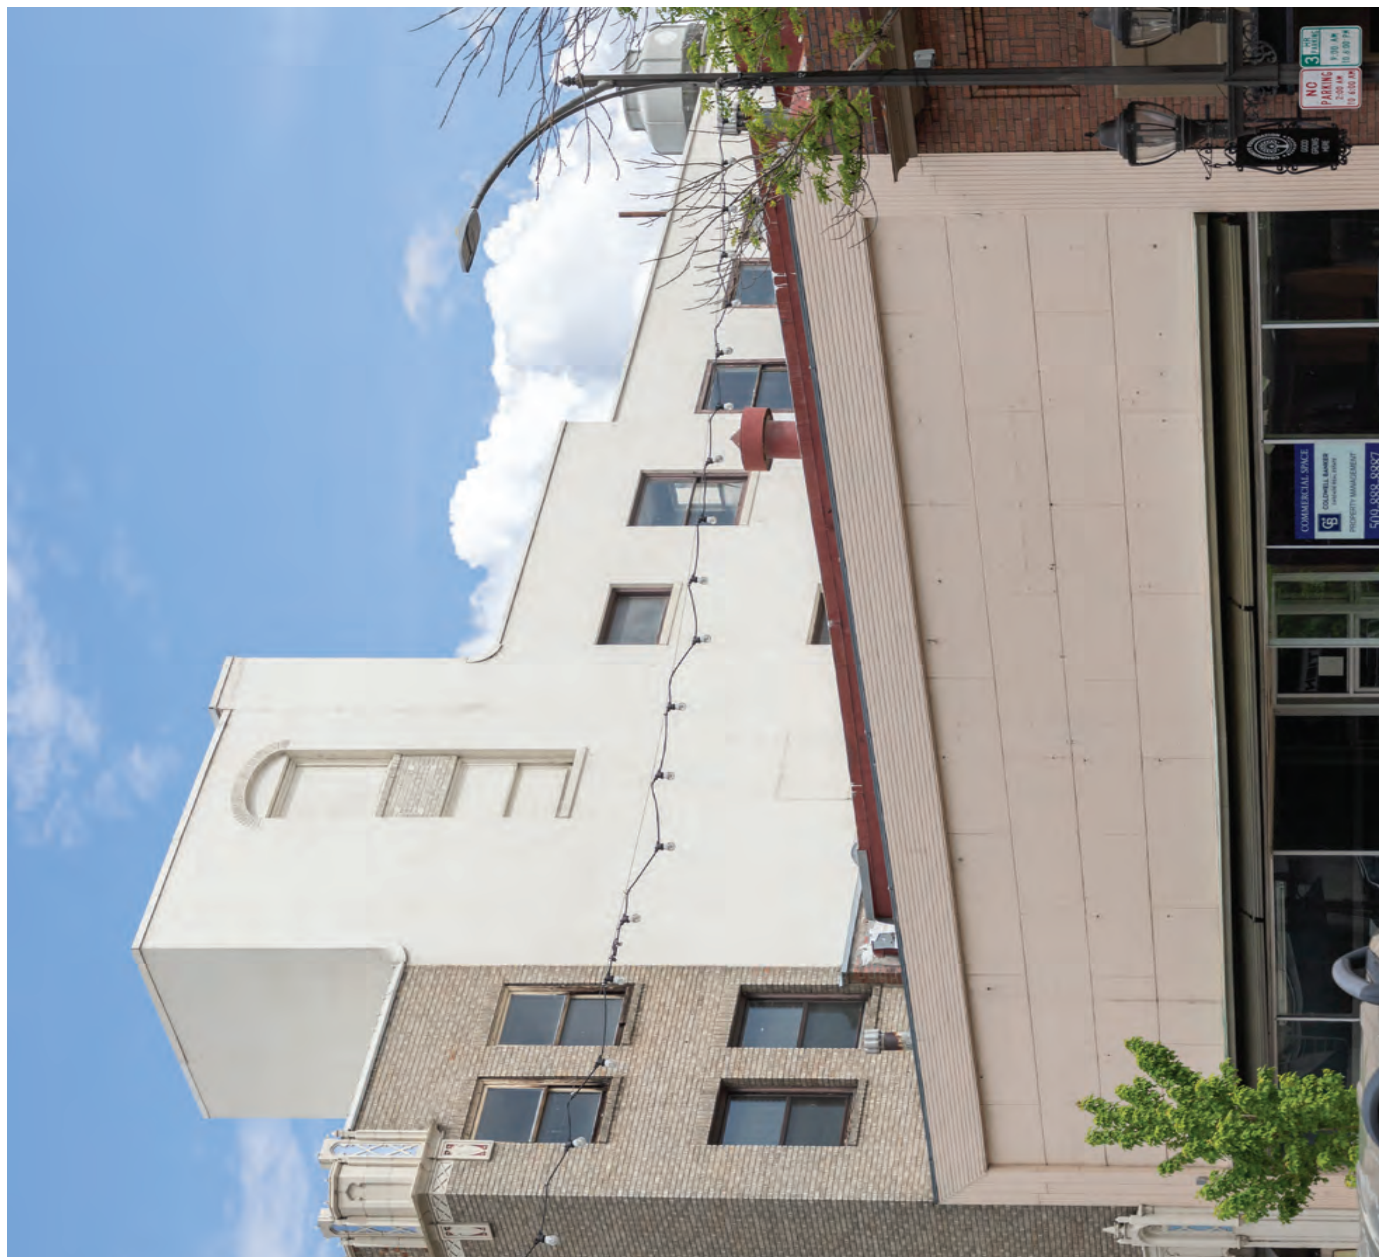
Fig. 20. South facade, west and central portions (above left) and east portion (above right) showing typical conditions.

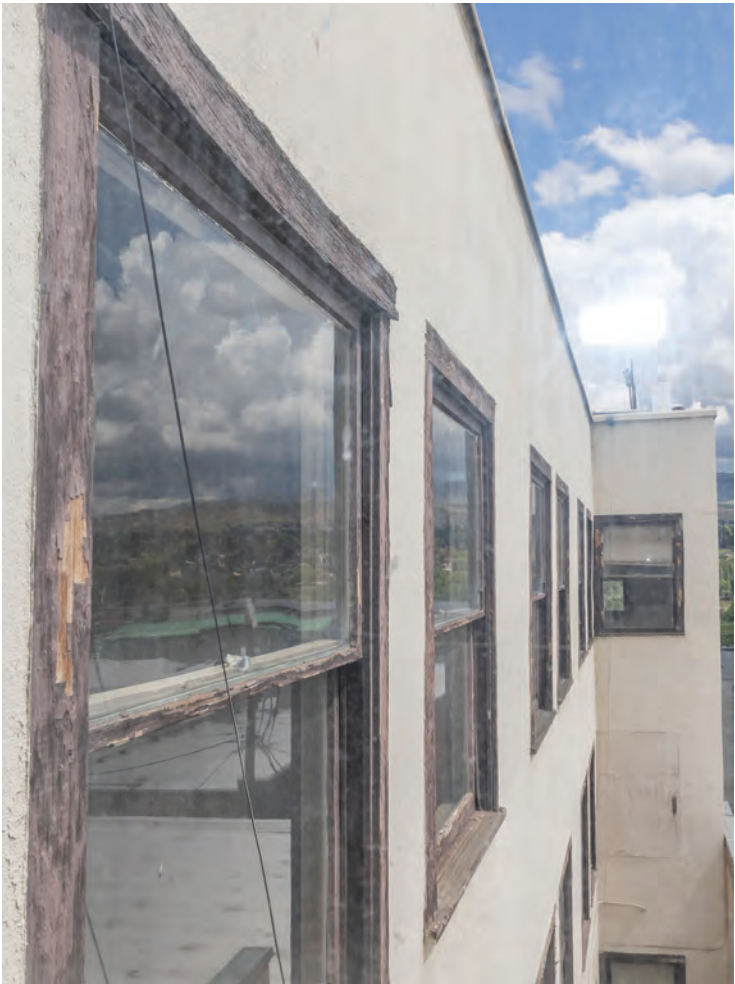
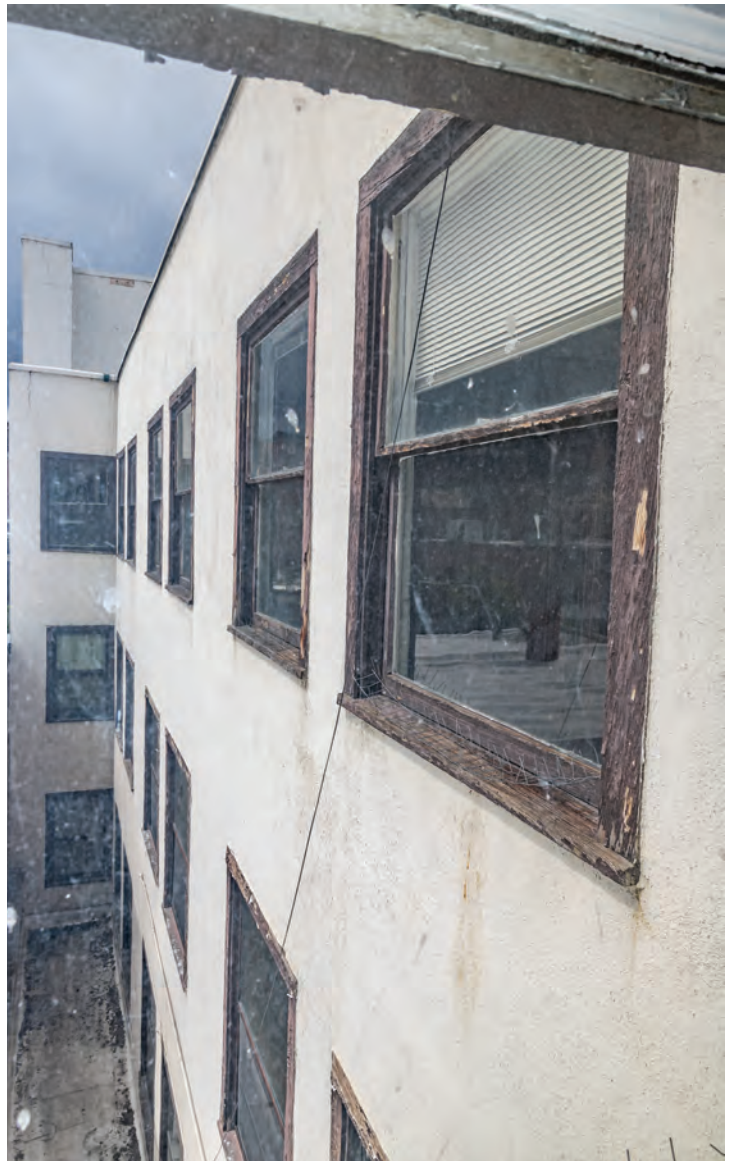
Fig. 21. South light well, looking east (above left) and looking west (above right) showing existing conditions.

- Wood lug sills**, wood, painted, original. On south facade within the light well. Wood, painted, square stock. Replace with new poly-ash or similar smooth surface exterior grade paintable casing suitable for this high solar exposure (extreme heat) location. Match existing sill dimensions. Existing sills exhibit significant deterioration due to high sun exposure. Match paint color to new retrofit sash system paint color.

- Exterior wood casings** occur only at the south light well. Wood, painted, square stock. Replace with new poly-ash or similar smooth surface exterior grade paintable casing suitable for this high solar exposure (extreme heat) location. Match existing square stock casing dimensions. Existing casings exhibit significant deterioration and warping due to high sun exposure. Match paint color to new retrofit sash system paint color.

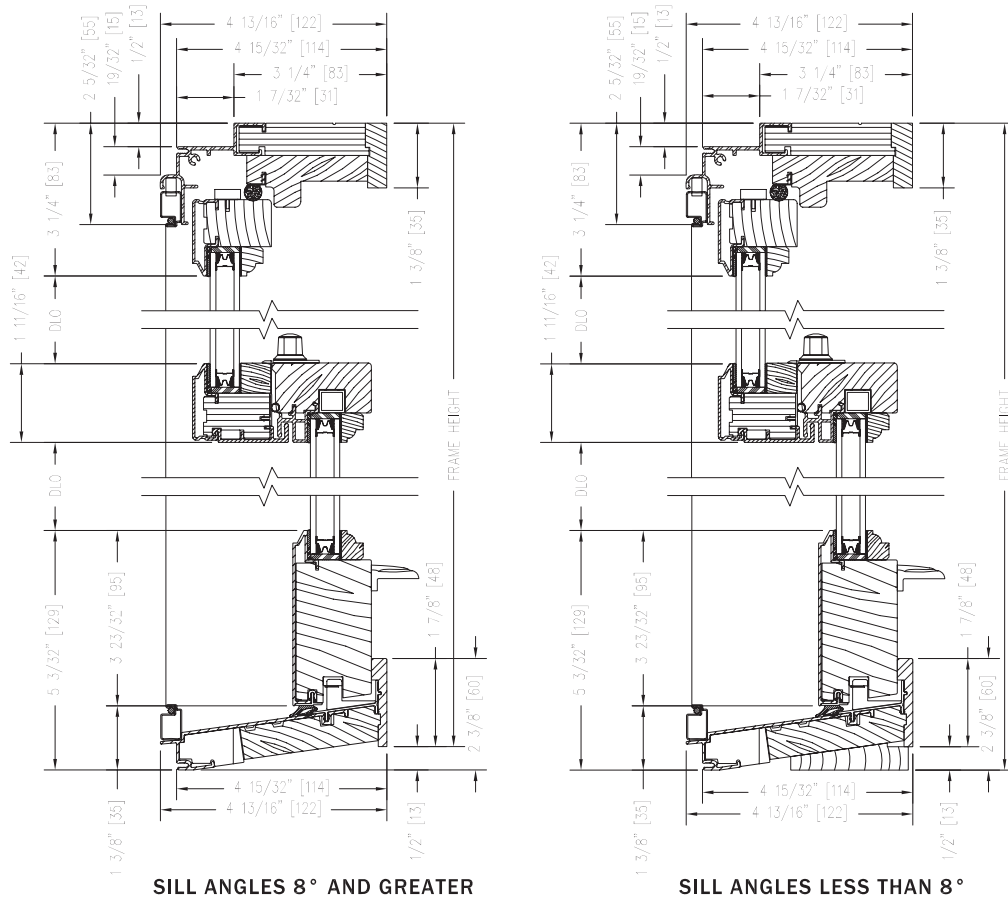
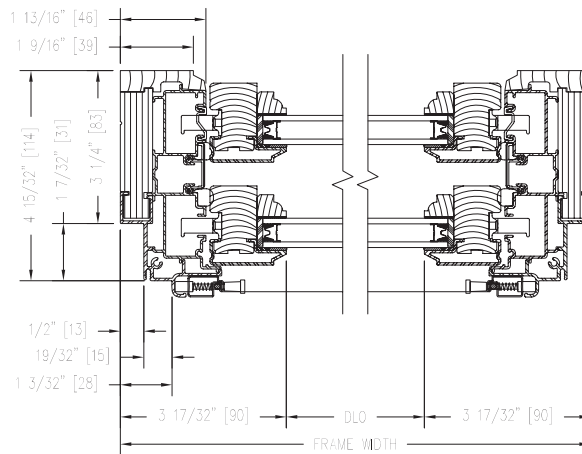
Fig. 22. Retrofit window system section details.

DOUBLE HUNG RETRO-FIT

Proposed work will replace second, third, and fourth story windows with new retrofit sash systems. Installation will retain original frames, brick moldings, and interior trim, and remove existing sashes. The new retrofit sash system and metal pan flashing at the sills will be installed from the interior. No work at first story windows or storefronts. The attached facade maps show existing windows and proposed work.
