WENATCHEE HISTORIC PRESERVATION BOARD
REGULAR MEETING
August 2, 2023

Description of Request: This is an application for a Certificate of Appropriateness submitted by Spencer Howard, Northwest Vernacular, Inc., representative for the property owner, Michael Fleming, Wenatchee S & L, LLC. The proposal is to replace the windows and sash on the 2nd through 4th floors on all the facades. The building is listed on the Wenatchee Register of Historic Places. Application materials are included as Attachment A.

Project description: The proposal is to replace the windows and sash on the 2nd through 4th floors on all the facades. A detailed narrative and architectural drawings are provided as a part of Attachment A.

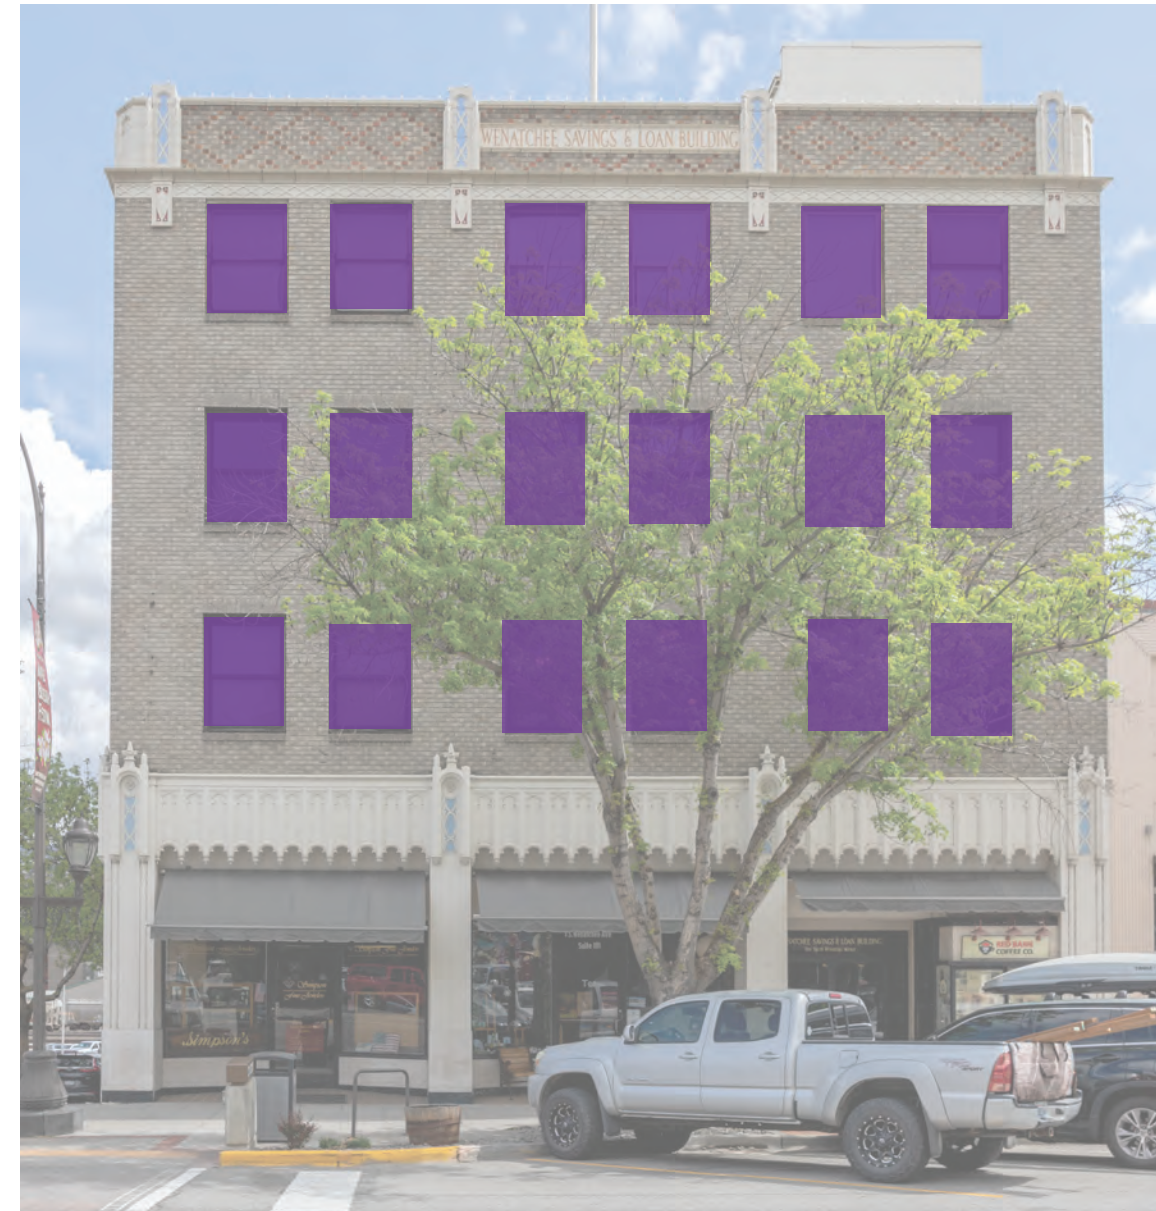
Fig. 28. West facade (fronting S Wenatchee Avenue) treatment approach.

- No Work: Existing frame and sash in good repair, no work needed beyond routine maintenance.
- New/Replacement Work: Retain and repaint original frame and brick molding. Replace in-kind and paint any missing brick molding. Remove existing sashes. Install new retrofit sashes system from interior. Install metal pan flashing over wood sill. No changes to brick sub sill.

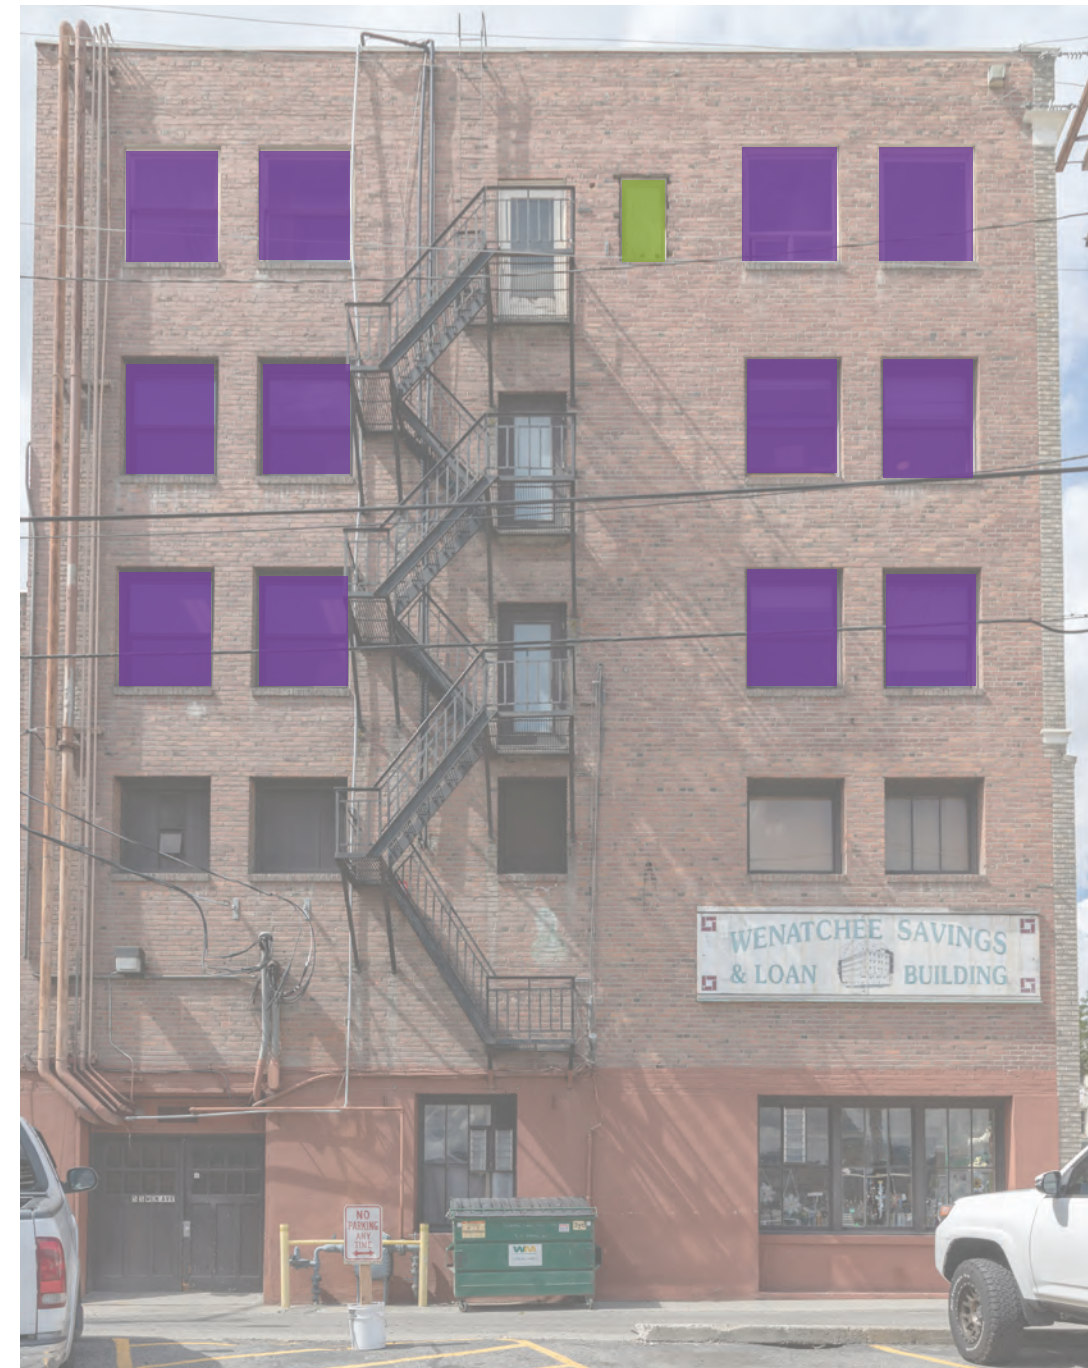
Fig. 32. East facade treatment approach.

- No Work: Existing frame and sash in good repair, no work needed beyond routine maintenance.
- New/Replacement Work: Retain and repaint original frame and brick molding. Replace in-kind and paint any missing brick molding. Remove existing sashes. Install new retrofit sashes system from interior. Install metal pan flashing over wood sill. No changes to brick sub sill.

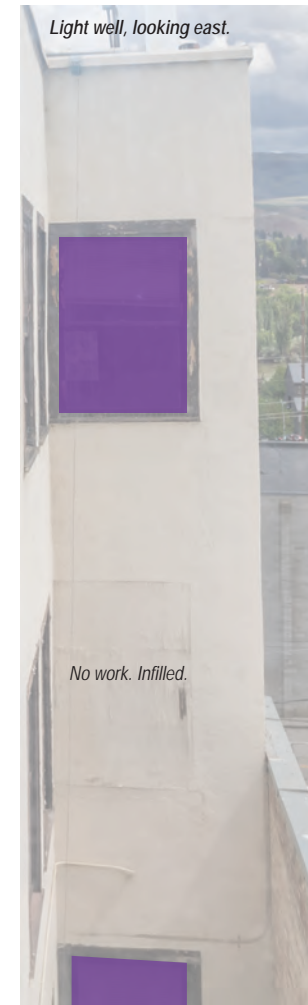
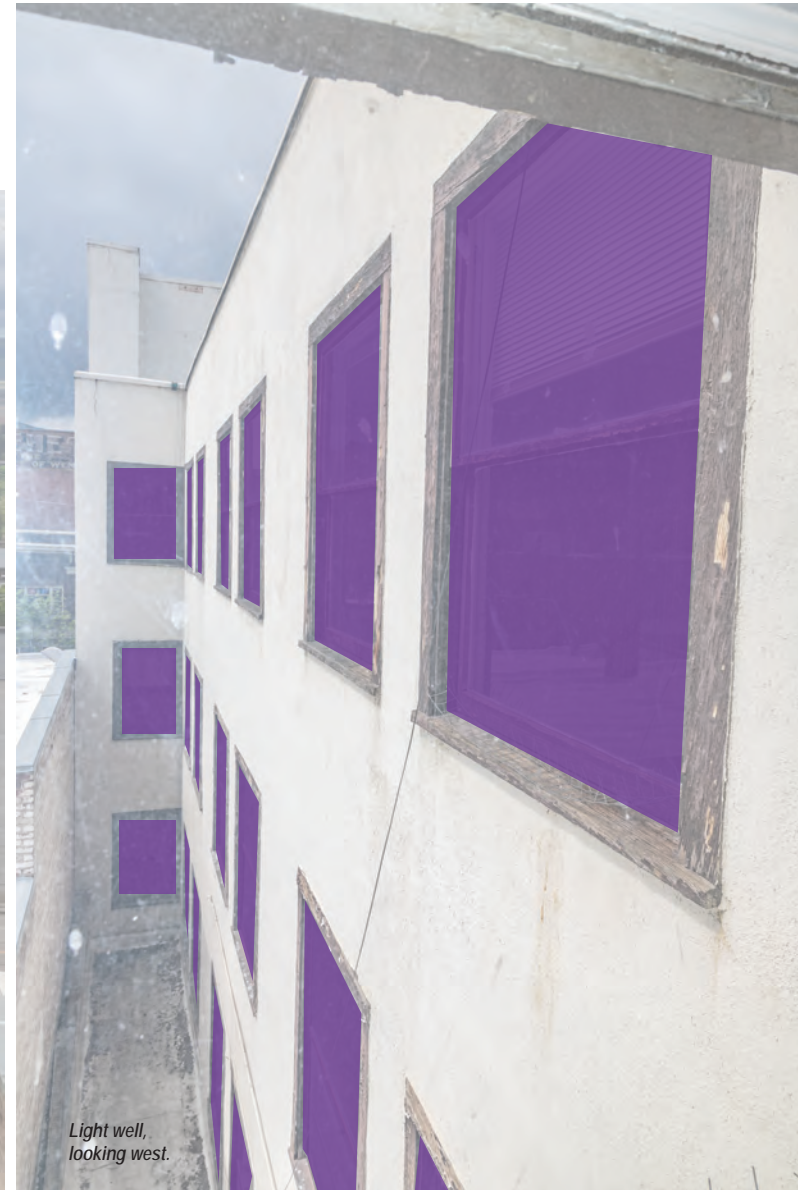
- No Work: Existing frame and sash in good repair, no work needed beyond routine maintenance.
- New/Replacement Work: Retain and repaint original frame and brick molding. Replace in-kind and paint any missing brick molding. Remove existing sashes. Install new retrofit sashes system from interior. Install metal pan flashing over wood sill. No changes to brick sub sill.
