PUBLIC WORKS

AT WORK

Our 8 million gallon reservoir (8 mil) was built in the early 1960's due to a growing population and water demand in the Wenatchee valley. This reservoir along with our 4 million gallon reservoir are crucial infrastructure for our Cities drinking water. The levels of water in both these reservoirs is continuously monitored by our software system which signals the pumps when to send more water from the aquifer to maintain set water levels in the reservoirs.

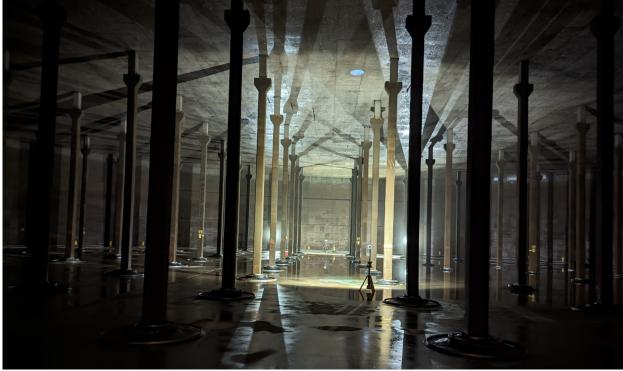
Picture 1: Inside the 8 Mil Reservoir, looking at some of the 109 pillars.

Inside the reservoir there are 109 pillars holding up the roof. At each pillar and around the inside joint between the reservoir wall and floor there is a rubber seal to prevent the water from leaking out. City Staff and the Consultant found failures in the seals likely due to age (70+ years) and

suspected that most of the leaking was attributed to these seal failures. Some temporary repairs were installed, but the reservoir needed to be refilled as soon as possible before the spring and summer peak water-use begins.

Now that we have diagnosed the problem a permanent repair solution will be determined and final repairs will be conducted during the winter of 2024-2025.

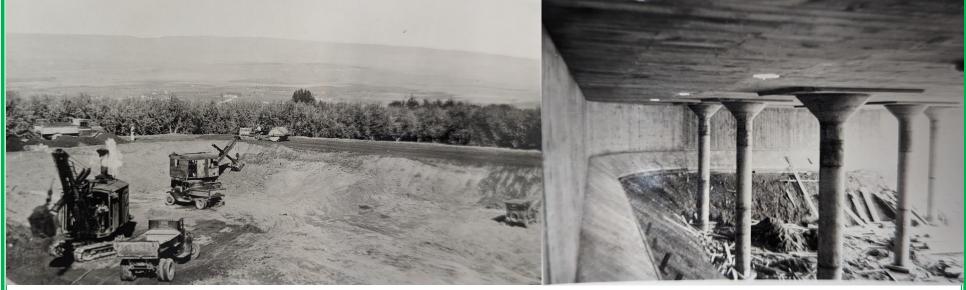
Picture 2: These photos were building the 4 Million Gallon Reservoir in 1931. You can see steam engines in use.

Picture 3: is the inside of the 4 Million Gallon Reservoir built in 1931. These are pillars similar to what is seen in the 8 mil reservoir.

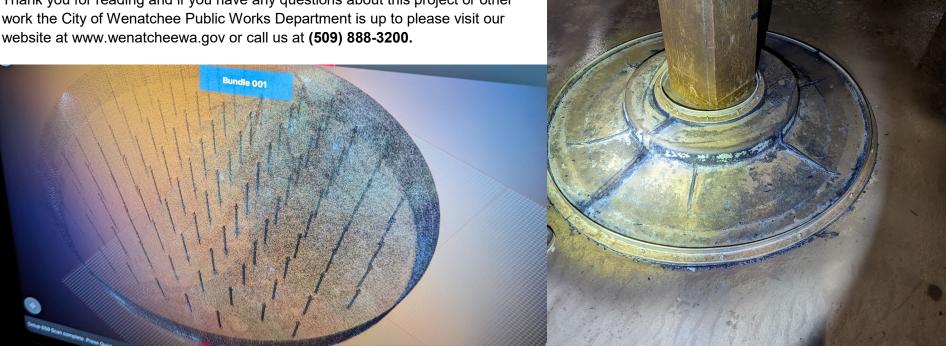
Picture 5: Scanning the inside of the 8 mil reservoir to help diagnose the issue.

Picture 4: Pillar with the seal and valves.
